Rainwater Management Performance of Newly Constructed Residential Building Enclosures During August and September 2004

Prepared for the Home Builders Association of Metro Orlando and the Florida Home Builders Association By:

January 11, 2005

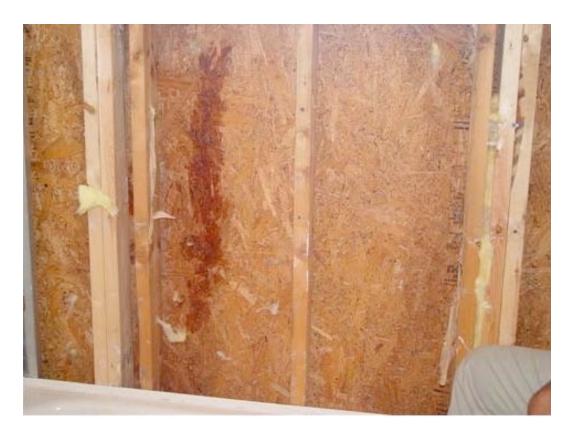
In the second floor frame assemblies water also penetrated the stucco via micro cracks. Again, as previously mentioned, typical paint finishes are unable to span micro cracks. In frame wall assemblies it is expected that this penetrating water will be drained back to the exterior. However, in many cases the penetrating rainwater was not drained to the exterior due to adhesion between WRB's and the stucco renderings preventing drainage between the stucco renderings and WRB's, a loss of water repellency of the WRB's and the lack of effective flashing at the base of the drained assemblies.

Photograph 2: Rainwater Entry into Second Floor Frame Assembly

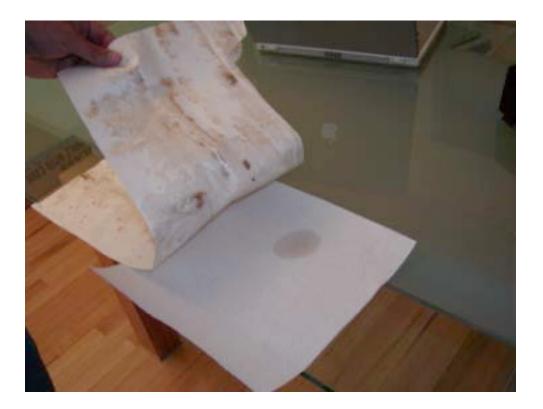
All perforated plastic housewraps fail a simple test for water repellency and water holdout (Photograph 5 and Photograph 6). Many non perforated housewraps fail a similar test when exposed to surfactants (Photograph 7, Photograph 8 and Photograph 9).

Photograph 6: Plastic Housewrap Failing Water Drop Test

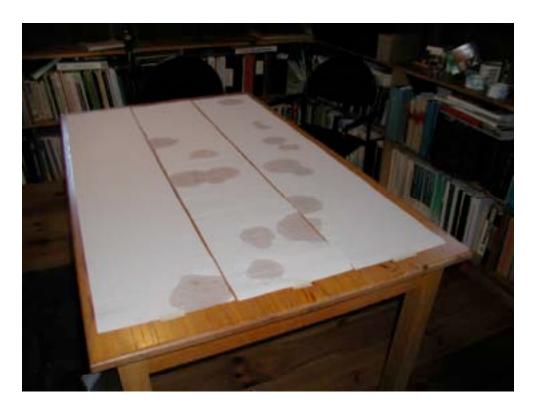
Photograph 9: Extensive Failure of Plastic Housewrap During Water Drop Test

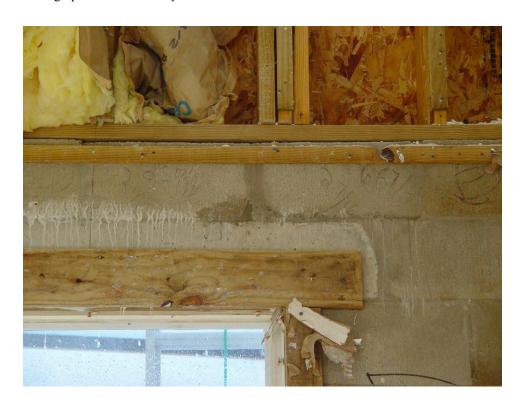
This practice results in leaks during wind driven rain events (Photograph 17) as the moisture storage capacity of the frame wall assembly is easily overwhelmed in the absence of drainage. The second floor frame assembly, which is a drained assembly is effectively unable to drain anywhere except to the interior.

Photograph 17: Water Entry Between Floors

The appropriate practice is to use a flashing between floors that effectively drains the water to the exterior (Figure 12). This detail is described in detail in Photograph 18, Photograph 19, Photograph 20, Photograph 21 and Photograph 22.

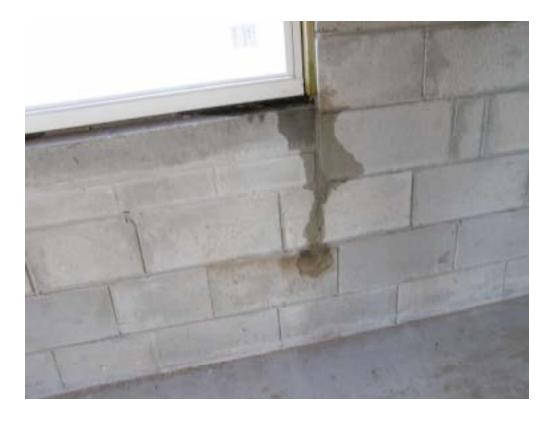
However, our testing indicates that many windows leaked at conditions well below their rated value -i.e. under no wind condition (Photograph 24 and Photograph 25).

Photograph 24: Window Corner Leakage

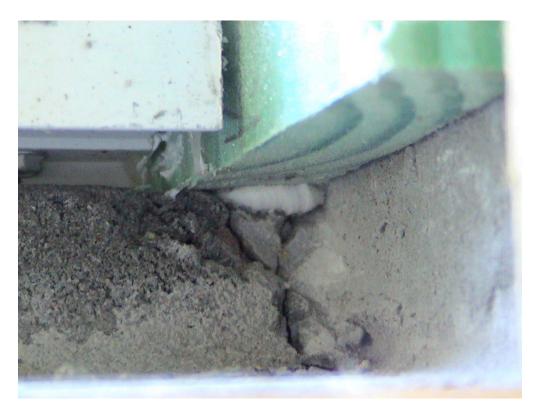
Photograph 25: Window Unit Leaking Inboard of Precast Attachment Rib

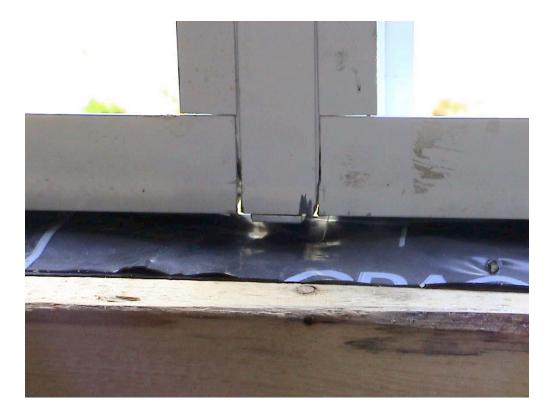
Additionally, many windows are sold as "mulled" or double windows or composite windows. However, they are tested as single units. Every mulled window unit tested leaked with no applied wind load (Photograph 26).

Photograph 26: Mulled Window Unit Leakage Paths

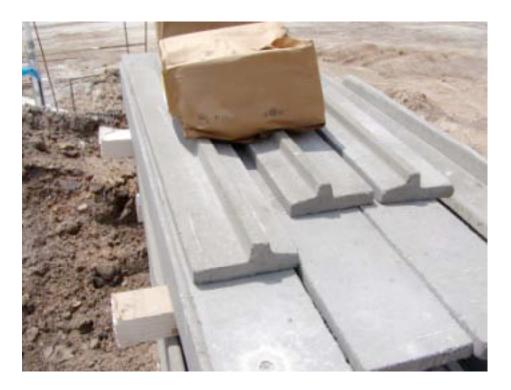
Many mass wall assembly window openings are constructed with precast sill units that have a raised rib attachment that directs window water leakage inwards rather than outwards (Photograph 27, Photograph 28, and Figure 13).

Photograph 27: Precast Sill With Illogical Attachment Rib

Figure 14 illustrates a precast sill profile that directs window water leakage outward. A similar approach is recommended for window openings in frame wall assemblies (Photograph 29).

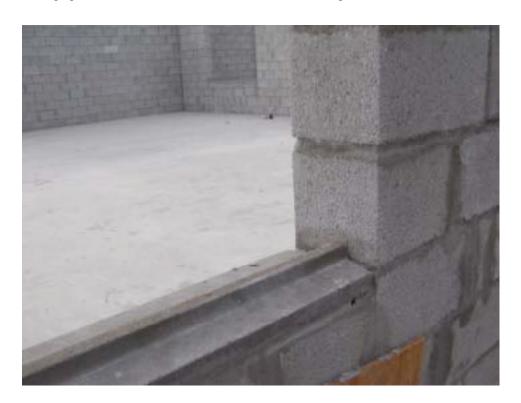
Photograph 28: Precast Sill That Channels Window Leakage Inward

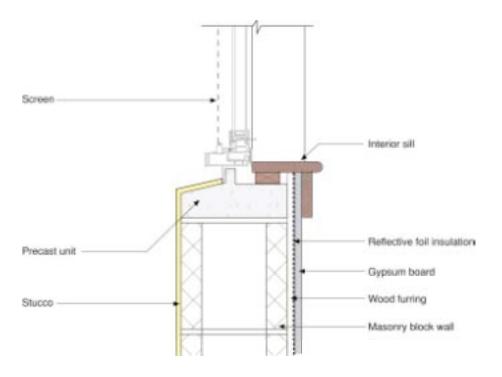
Figure 13: Current Practice That Directs Window Leakage Inward

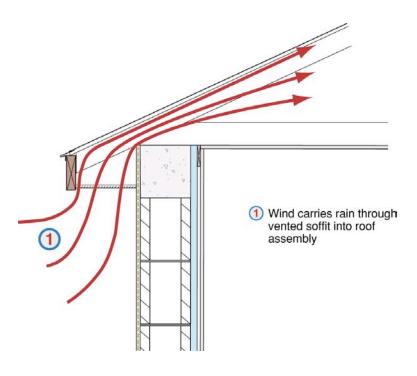
Anecdotal evidence indicates that a significant amount of rainwater entered soffit vent assemblies. This is consistent with the physics of the applied wind loads and the geometry of the soffit assemblies. Soffit geometries are currently not designed to address extreme wind driven rain exposures. Additionally, unvented roof designs which can address this mode of rainwater entry are currently not explicitly allowed in the Florida Building Code – although they are allowed in the International Residential Code.

Figure 15: Wind Driven Rain Entry In Vented Soffit Assembly

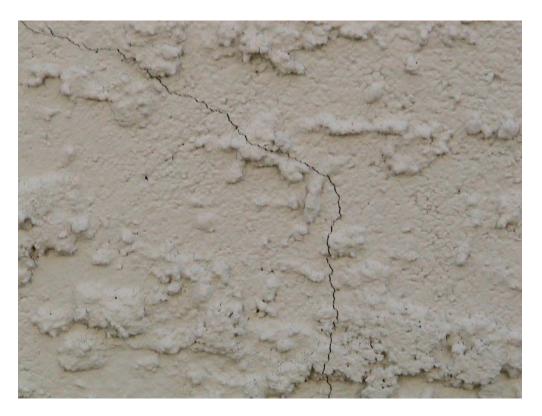
However, the presence of cracks (Photograph 60 and Photograph 61) caused all mass wall assemblies to pass water.

The type of crack shown in Photograph 60 is indicative of typical and expected stucco rendering crackage. Workmanship, quality control and cure impact the number and extent of shrinkage cracking. Soil conditions, the nature of the materials, geometry and aspect ratio of mass wall assemblies impact the number and extent of settlement cracking. However, the nature of stucco application, materials and substrates make it impossible to construct crack free monolithic stucco renderings – in other words shrinkage cracks and settlement cracks are to be expected.

Photograph 60: Typical Crack In Stucco Rendering

These shrinkage cracks and settlement cracks traditionally are handled through ongoing maintenance. At present, technology offers no other practical approach.

Increasing the moisture storage capacity of mass assemblies can partially address this issue. One approach is to construct a "seat" in the perimeter slab foundation to provide a reservoir for penetrating rainwater and to direct this rainwater to the exterior (Figure 20, Figure 21 and Photograph 62).

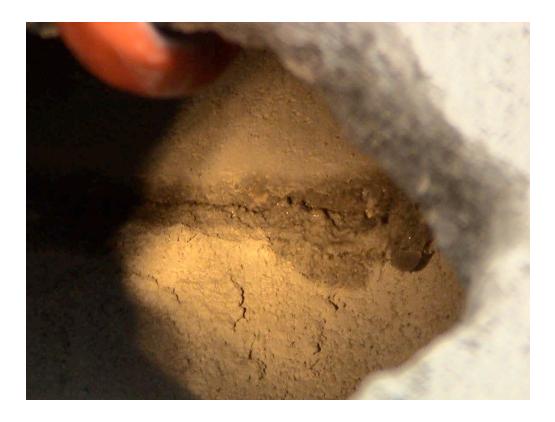
Photograph 61: Water Entry Associated With Typical Crack In Stucco Rendering
