Corrosion of Roofing Fastener Systems

Draft Final Report

June 14, 2016

University of Florida

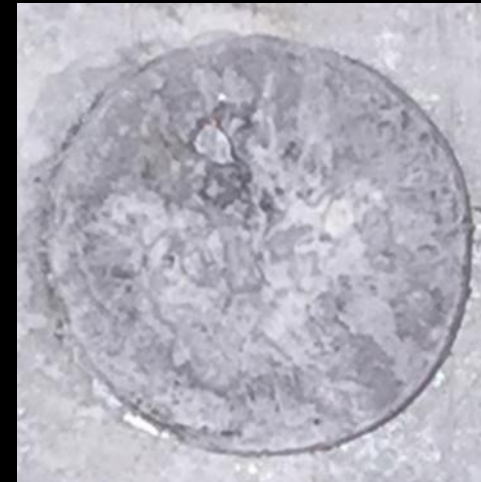
1: no corrosion observed

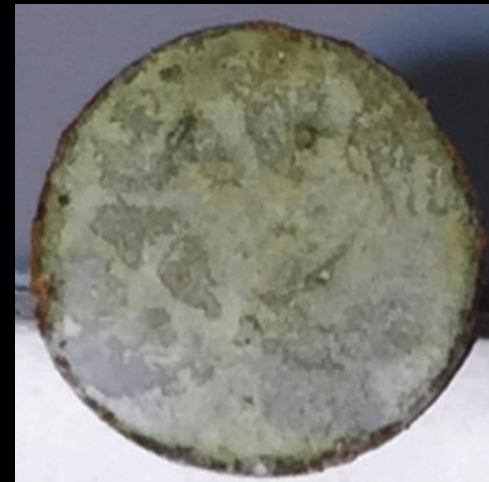
2: Edge corrosion only

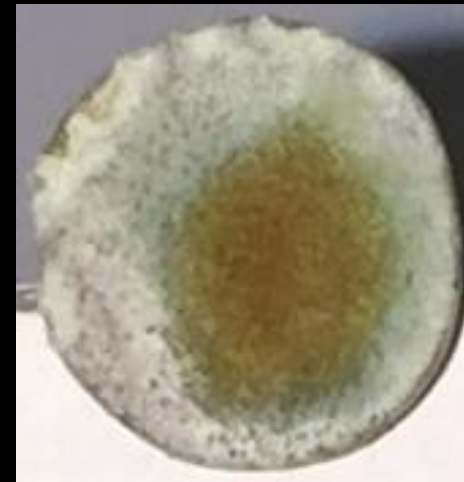
3: Light partial surface corrosion

most scores of 3 would fail TAS criterion of
> 5% surface corrosion

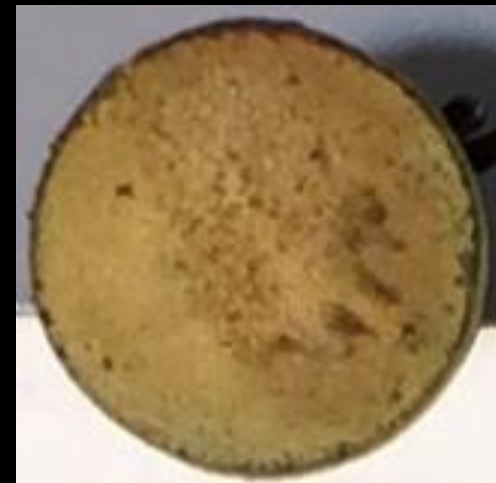
4: Light full surface corrosion

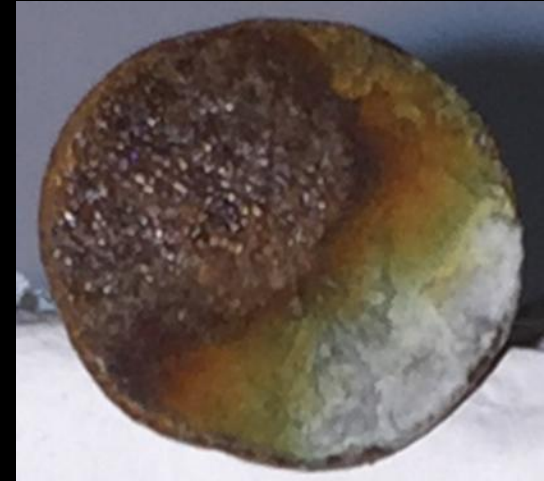
5: Partial heavy surface corrosion

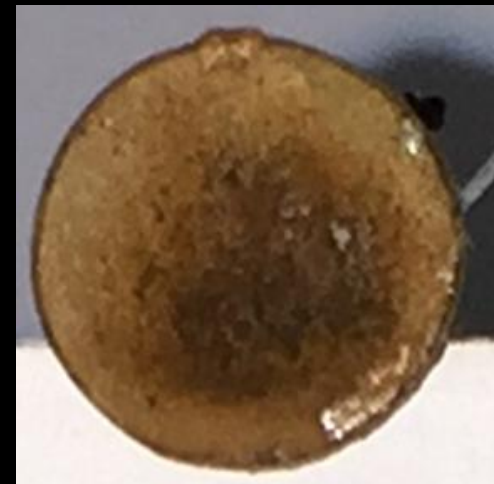
6: Partial heavy and partial light full surface corrosion

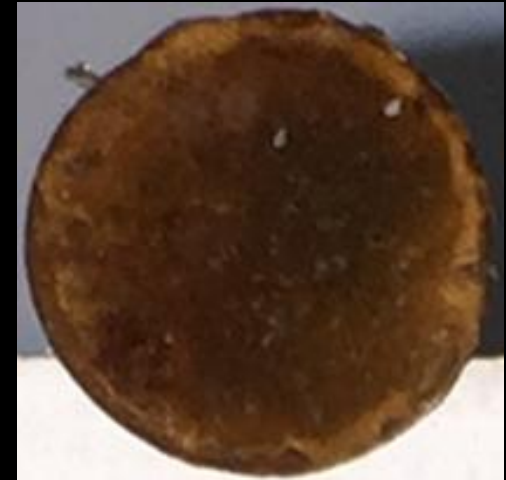
7: Heavy full surface corrosion without scaling

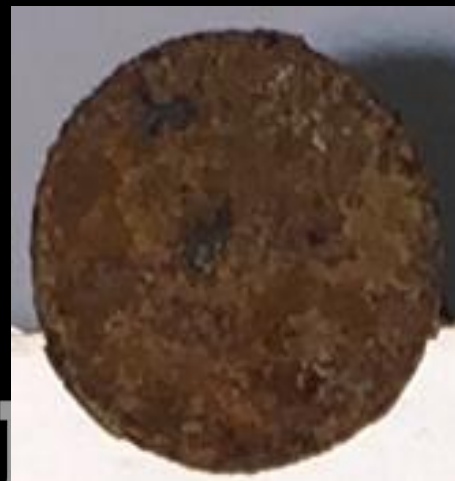
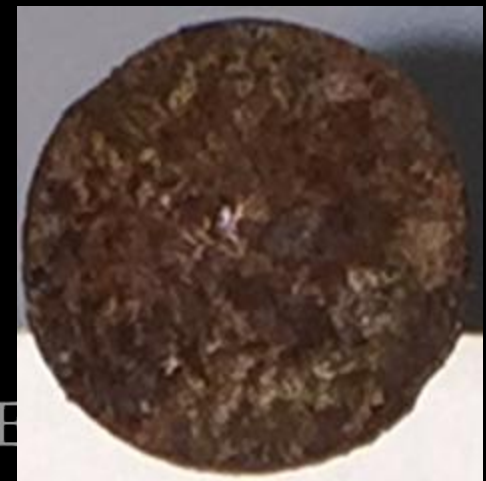
8: Heavy full surface corrosion with scaling

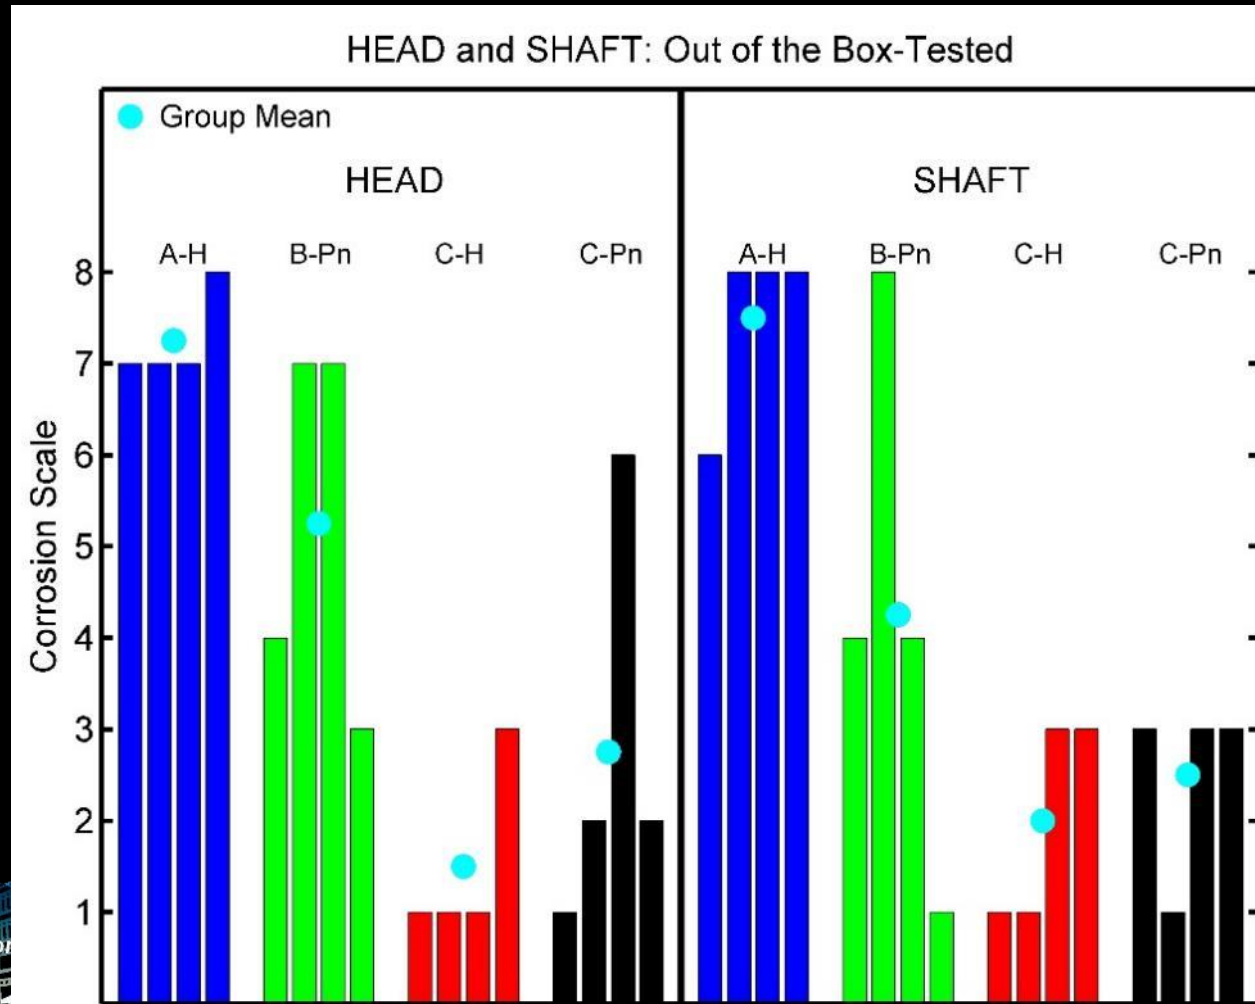
Corrosion scale results for 16 roof fasteners tested out of the box (configuration OB)

- Manufacturers C & D clearly shows better performance
- This set corresponds to the TAS 114 test specimen conditions

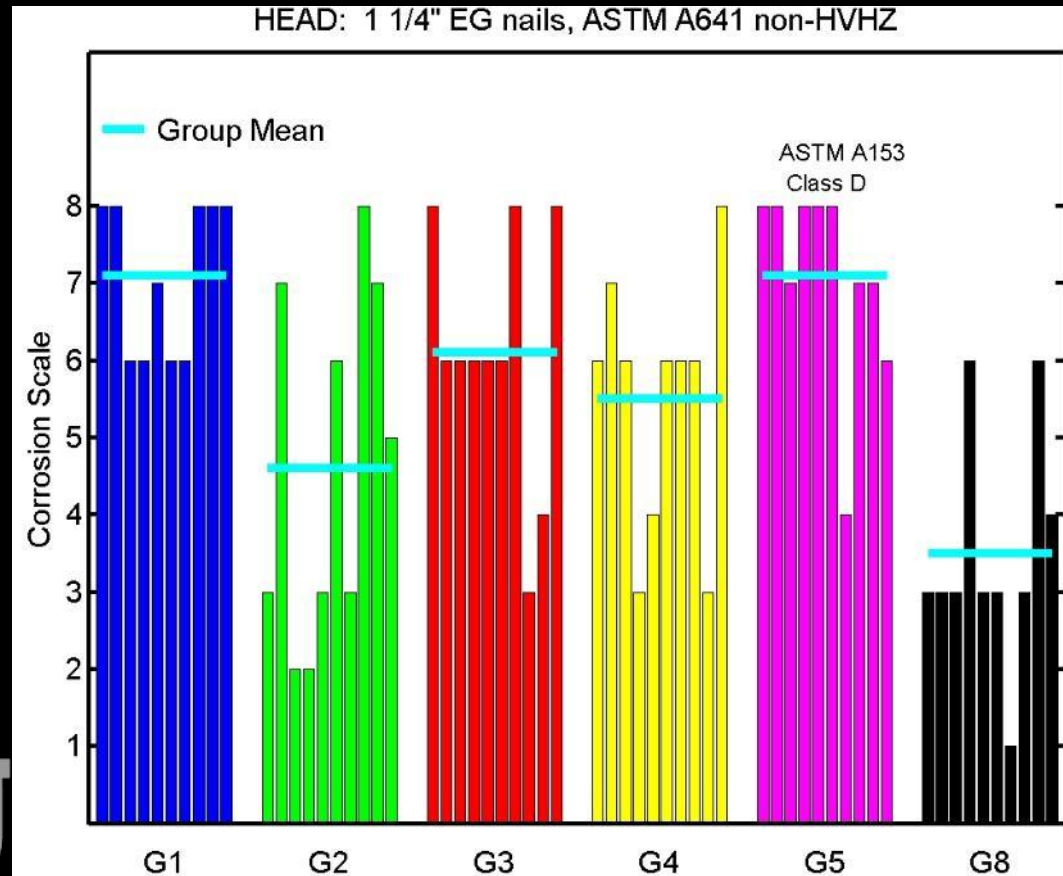
Figure I: All 1 1/4" electrogalvanized (EG) nails compliant with ASTM A641, **non-HVHZ**. Head results shown, shaft very similar

Generally, no improvement from 2014-2015 EG samples

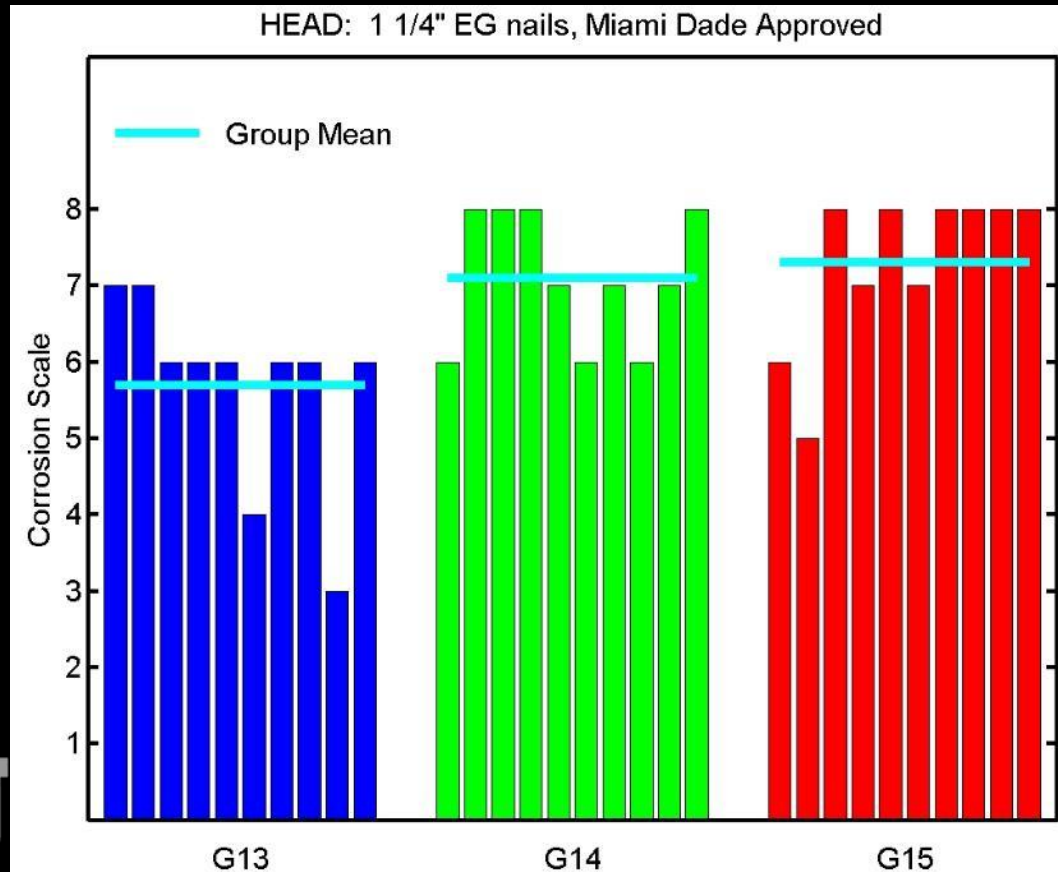
Figure 2: All 1 1/4" EG nails compliant with ASTM A641, HVHZ approved. Head results shown, shaft very similar

HVHZ approved EG no better than Non-HVHZ EG

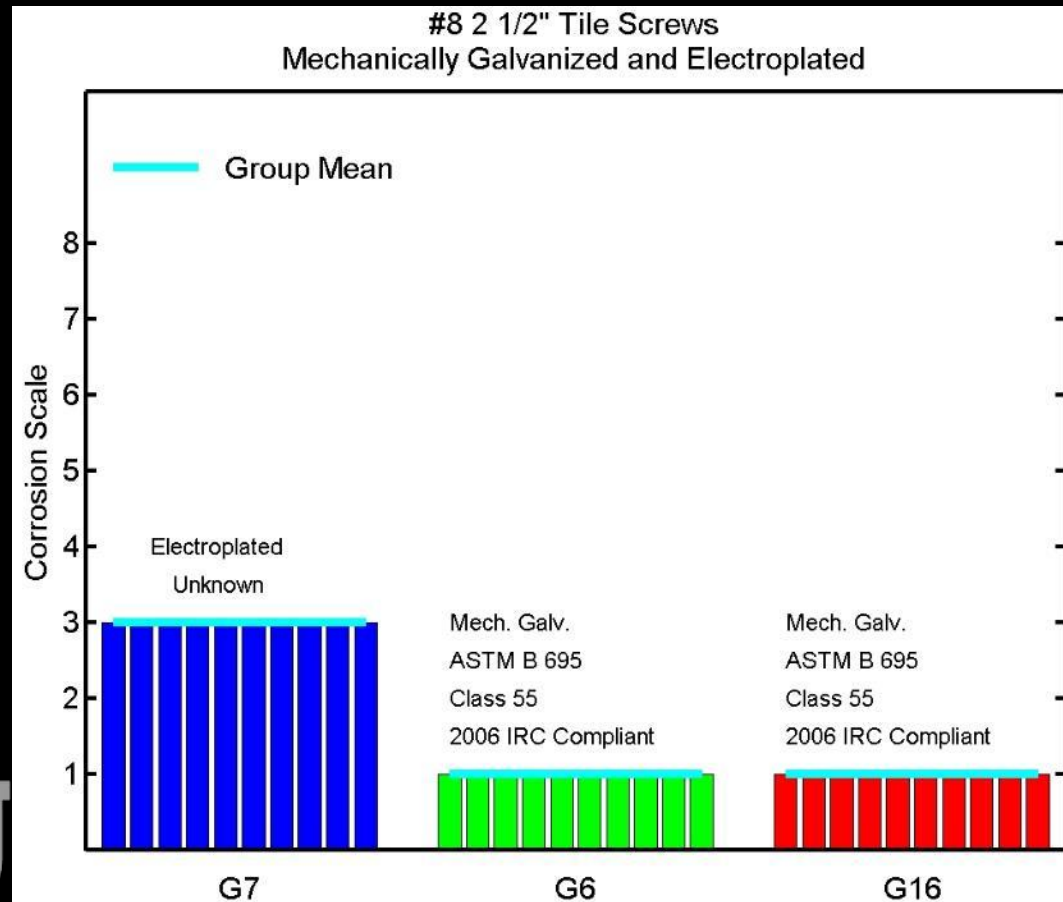
Figure 3: #8 2 1/2" roof tile screws, two mechanically galvanized specimens and one electroplated specimen. Head and shaft identical.

No visible corrosion on any sample of MG tile screws

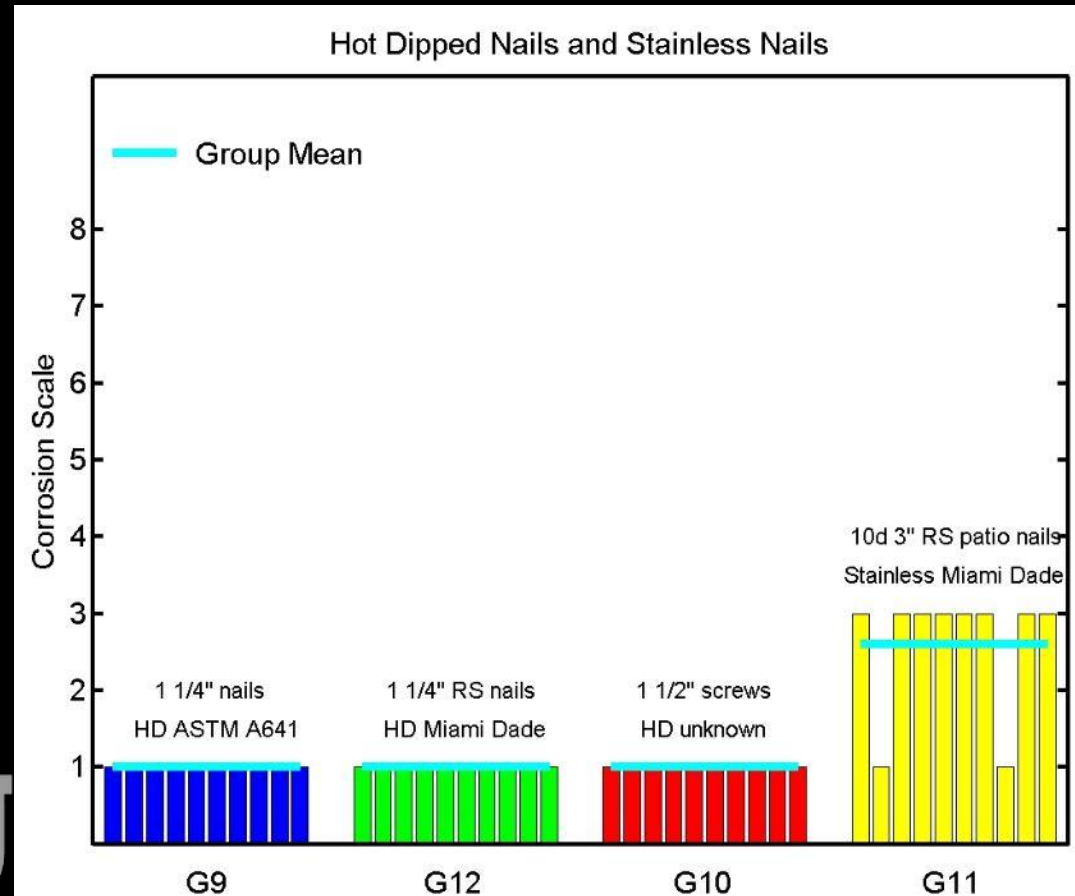
Figure 4: Two hot dipped 1 1/4" nail specimens, one hot dipped 1 1/2" screw enclosure fastener specimen, and one 10d 3" stainless steel patio/deck nail specimen. Head results shown. Shaft results identical.

No visible corrosion on any sample of hot dipped fasteners

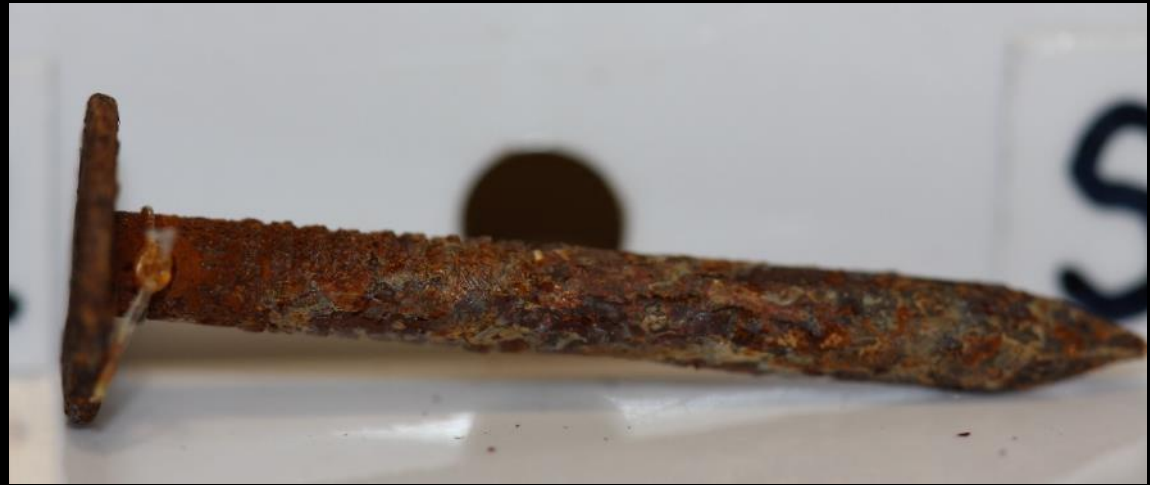
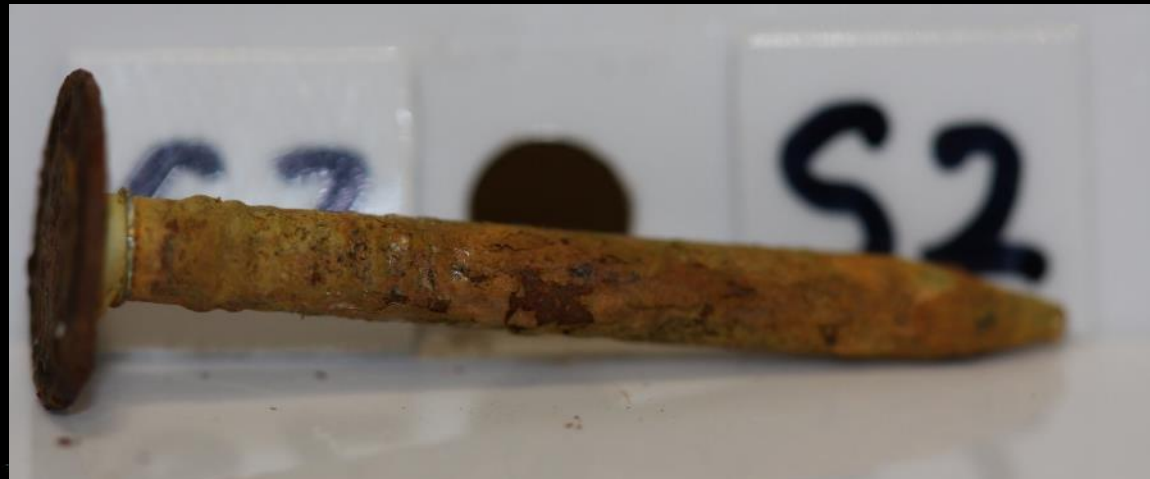
North Florida EG coil nail ASTM F1667 → ASTM A641

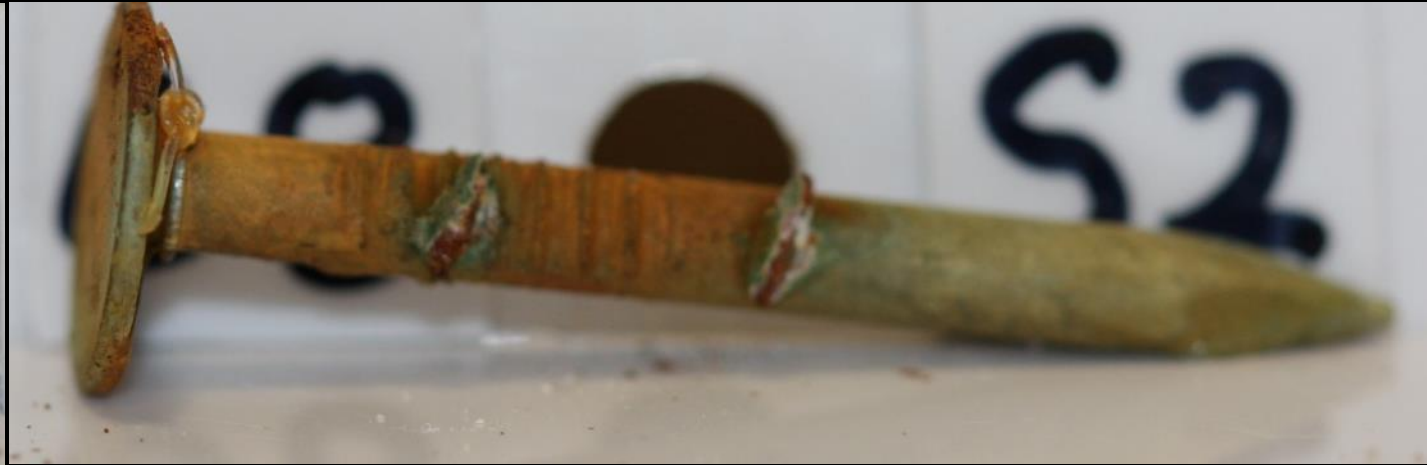
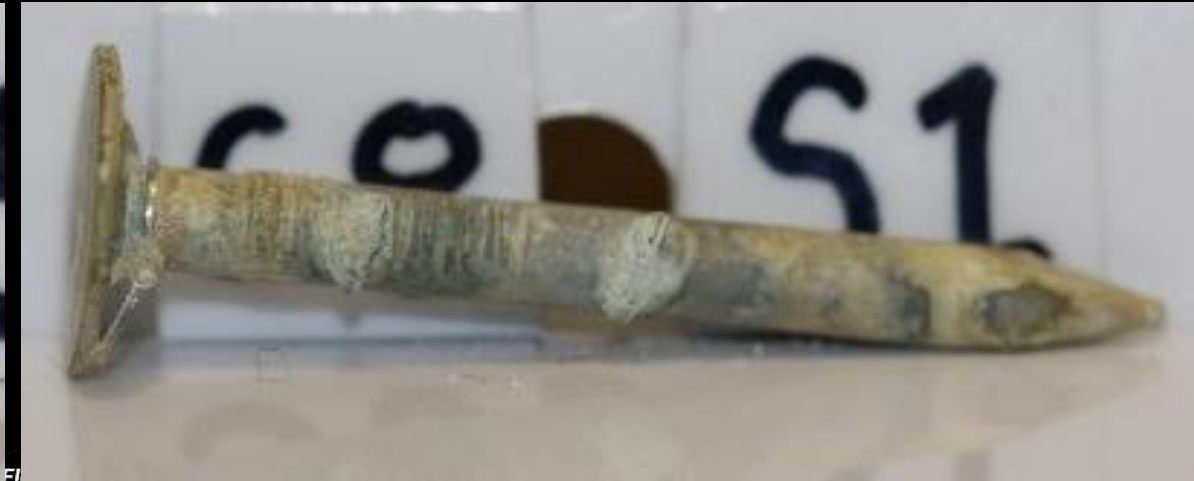
Central Florida EG coil nail ASTM F1667 → ASTM A641

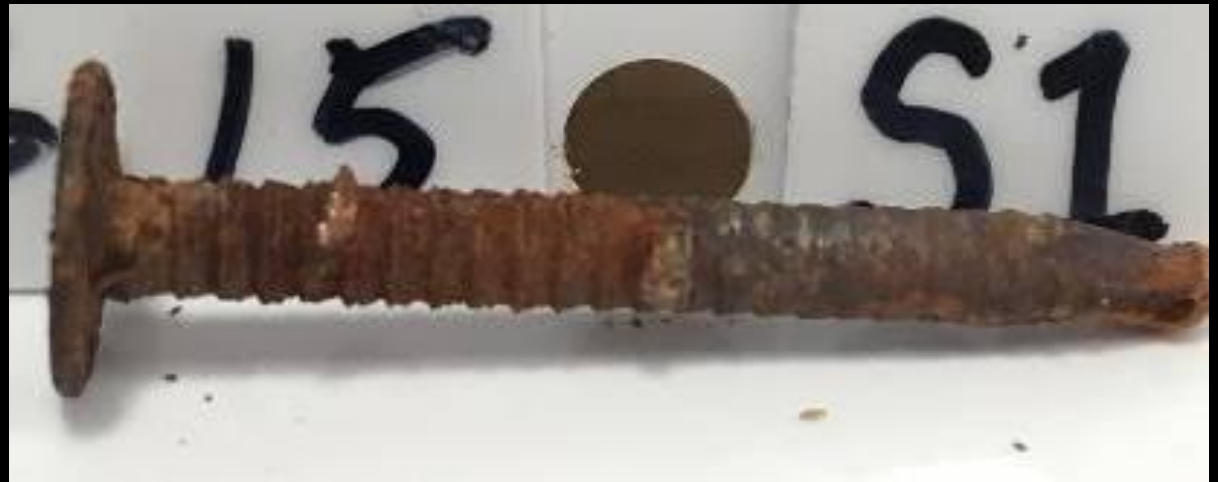
South Florida EG coil nail ASTM A641 HVHZ – Approved

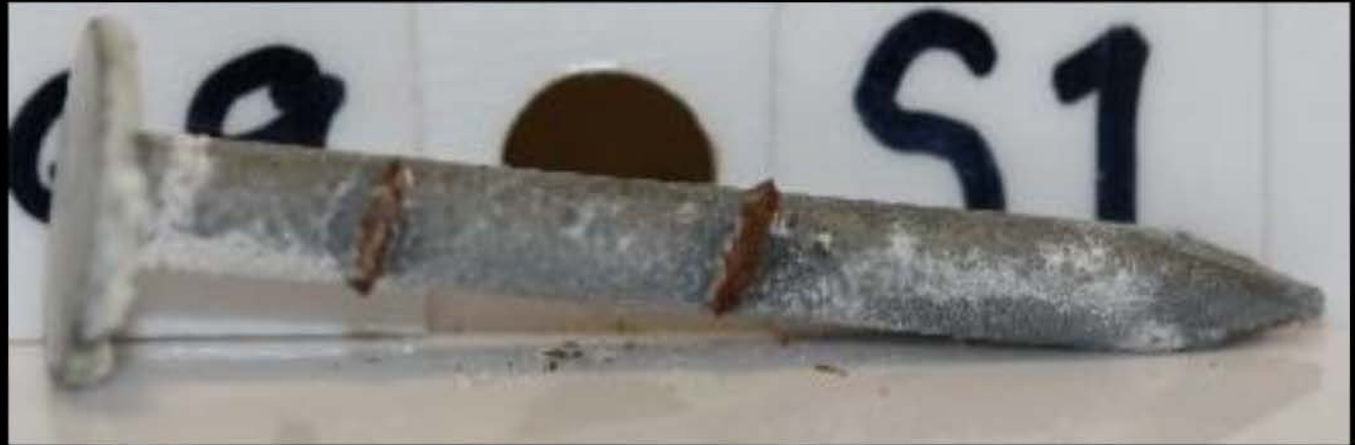
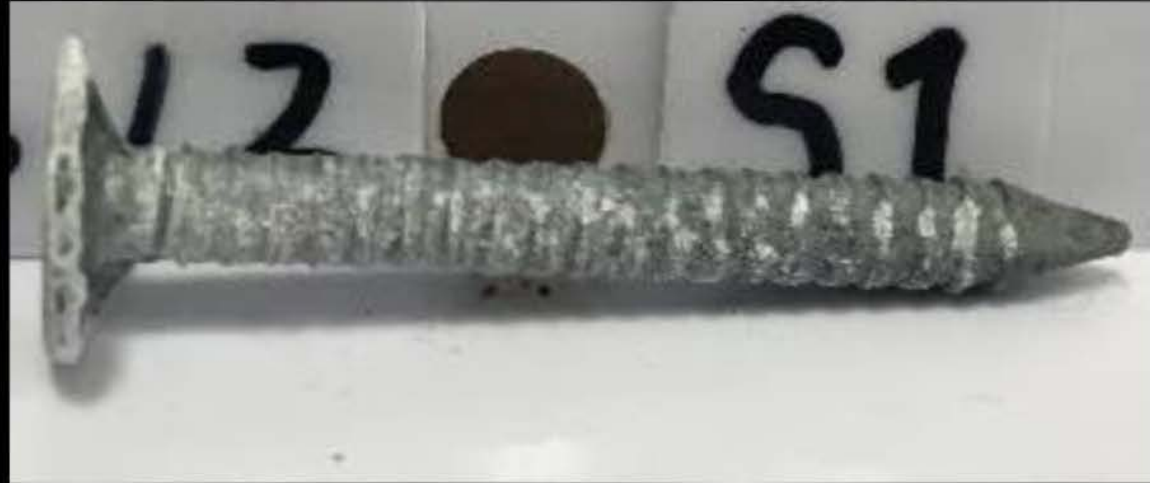
Hot dipped nails

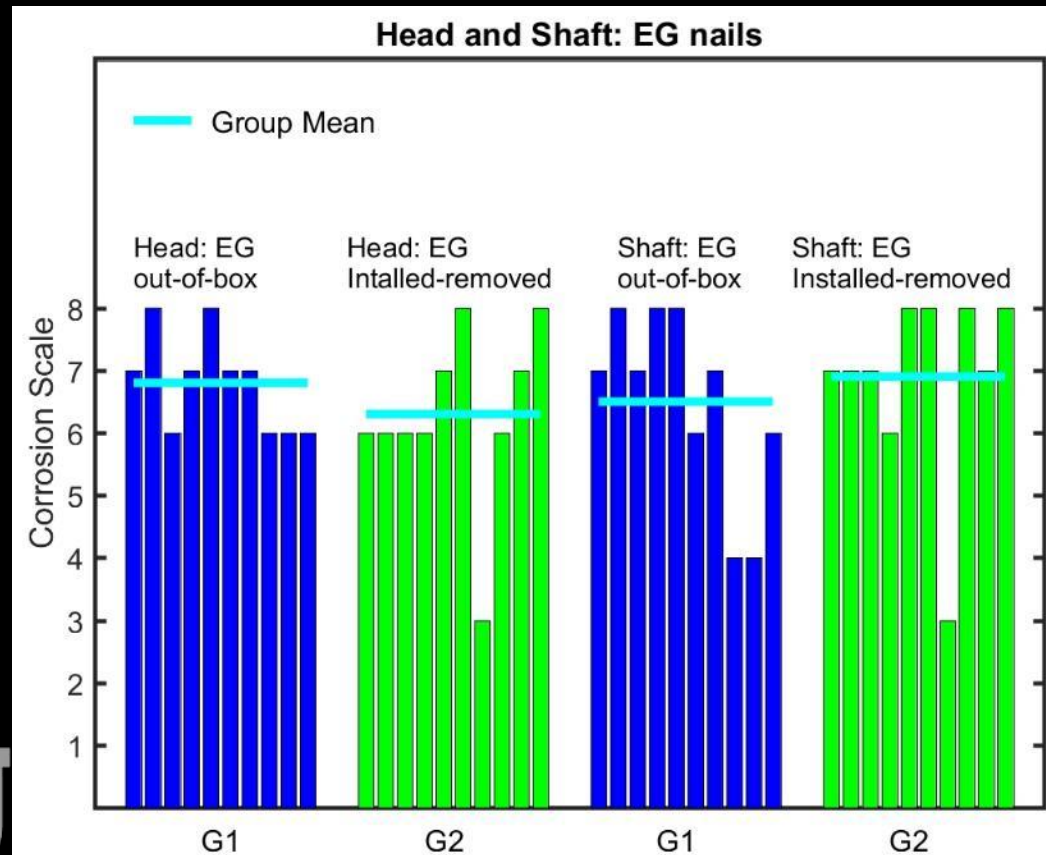
Figure 5: 1 1/4" EG nails, no certification marking. Blue: tested out-of-the-box. Green: installed-removed prior to testing.

Poor performance
Install has no influence

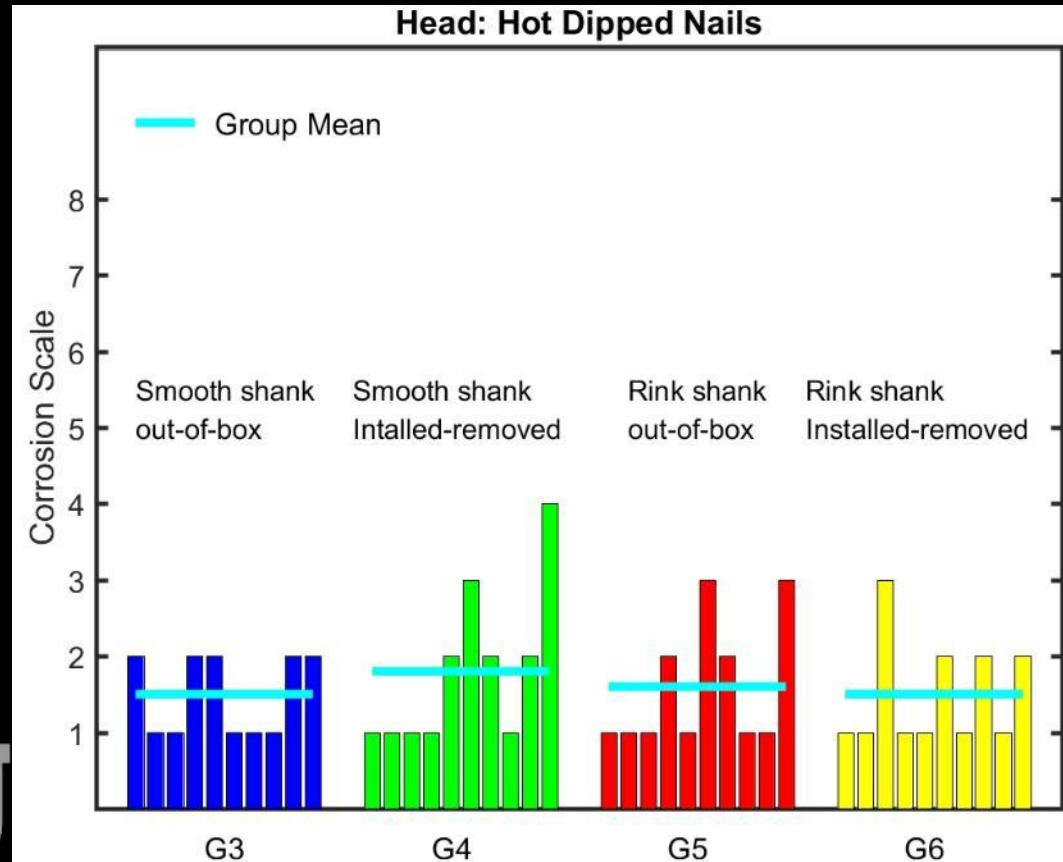
Figure 6: Test-2 1 1/4" Hot dipped nails, tested out-of-the-box and installed-removed as noted: Head results

Good performance
Install has no obvious influence

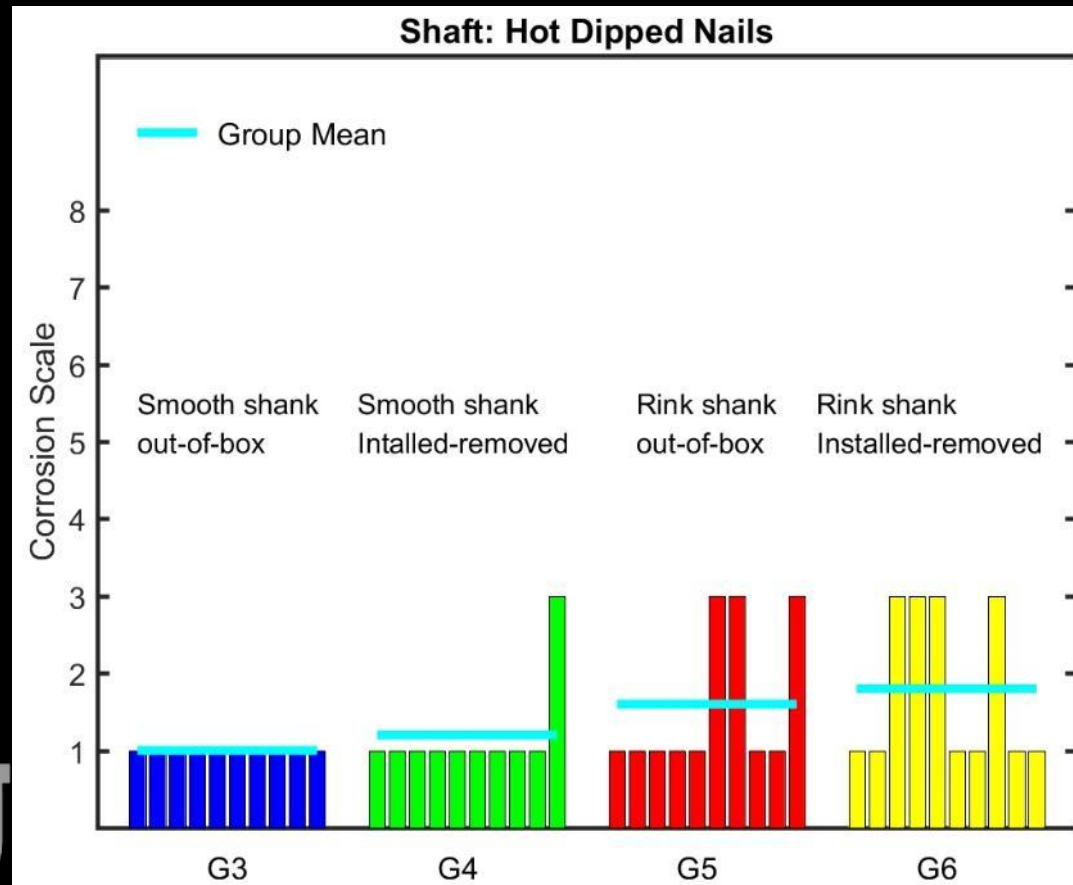
Figure 6: Test-2 1 1/4" Hot dipped nails, tested out-of-the-box and installed-removed as noted: Shaft results

Good performance
Install has no obvious influence

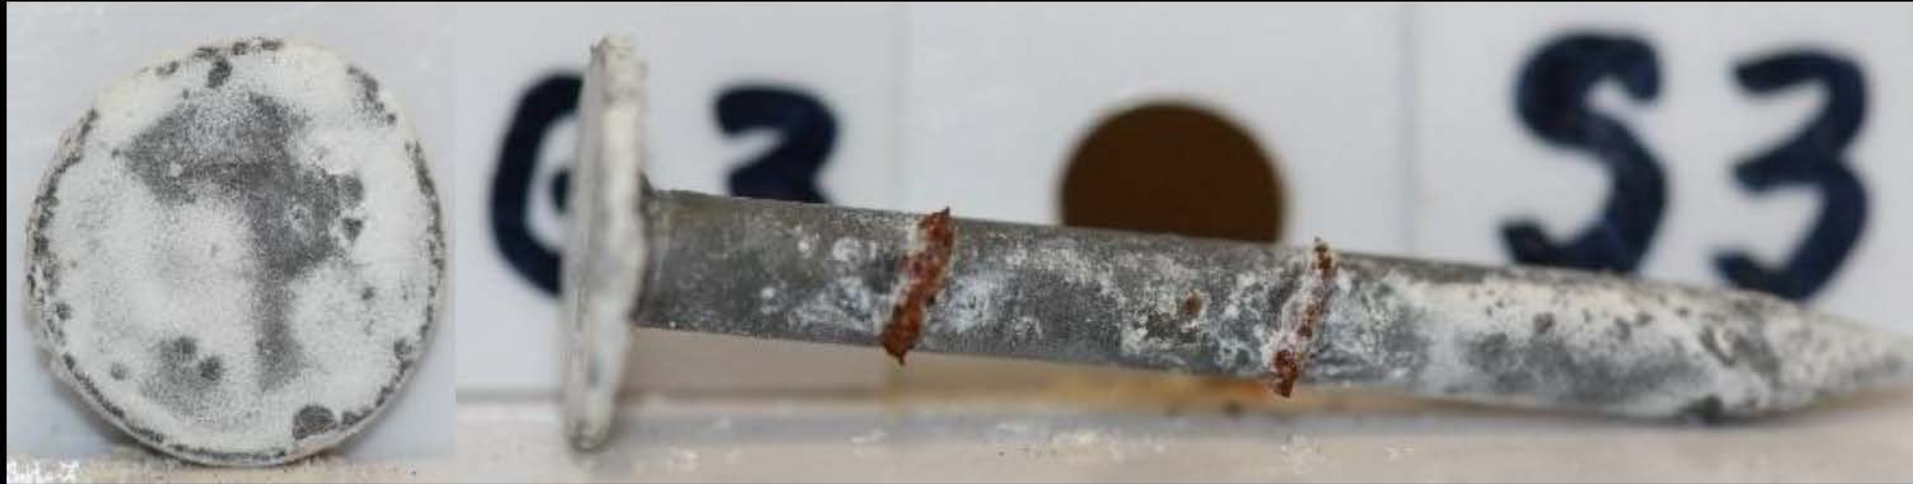
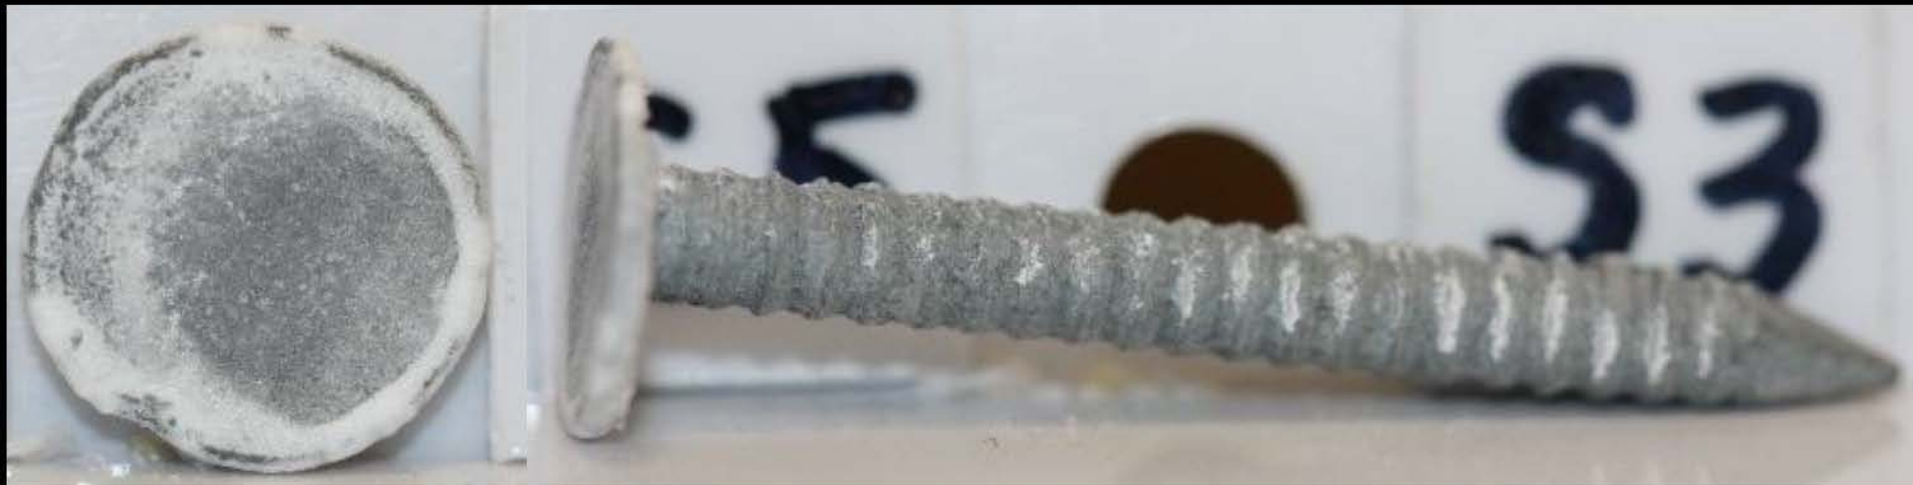
Test-2 hot dipped out of the box

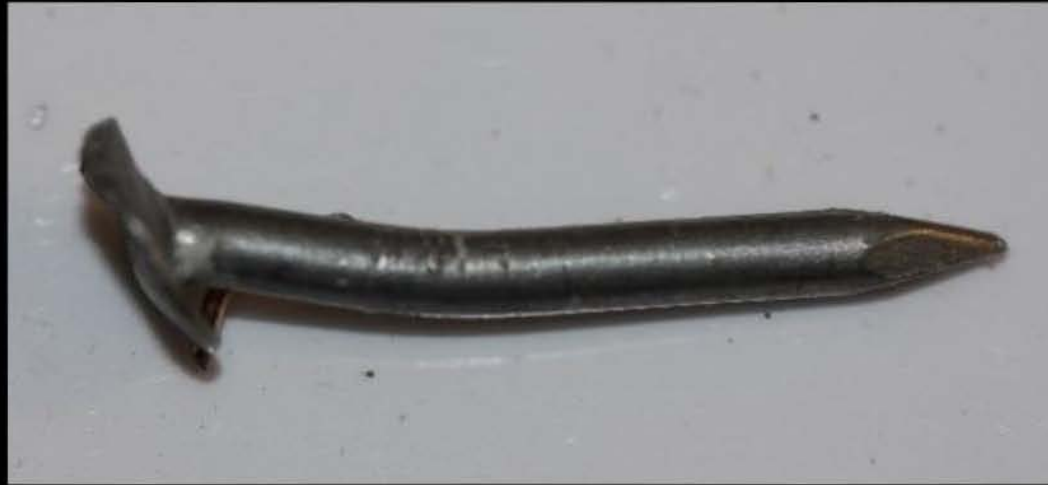
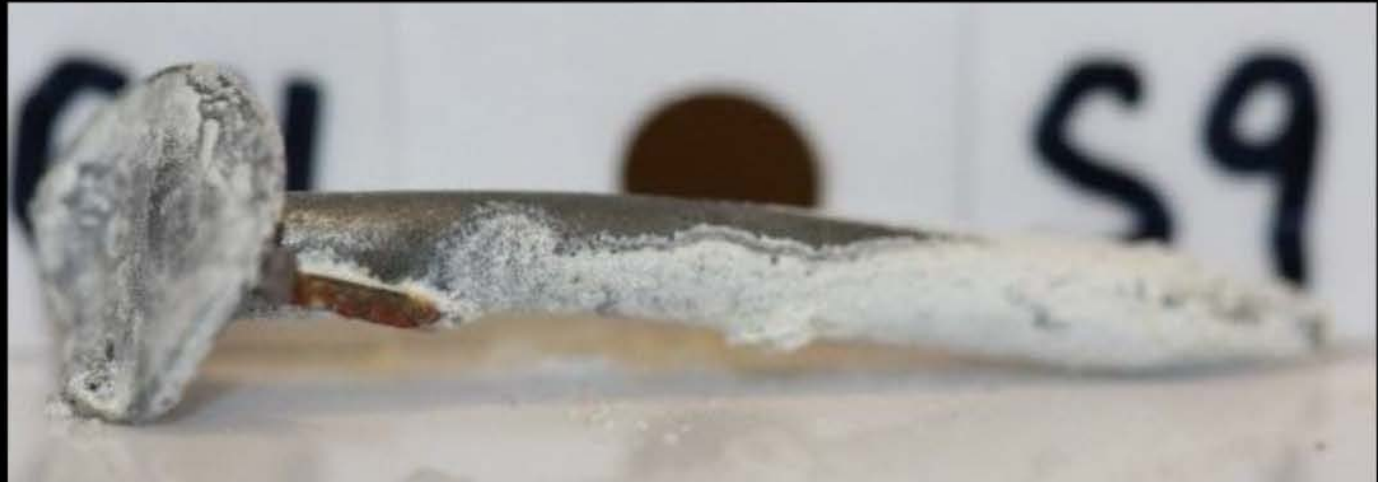
Test-2 hot dipped installed-removed

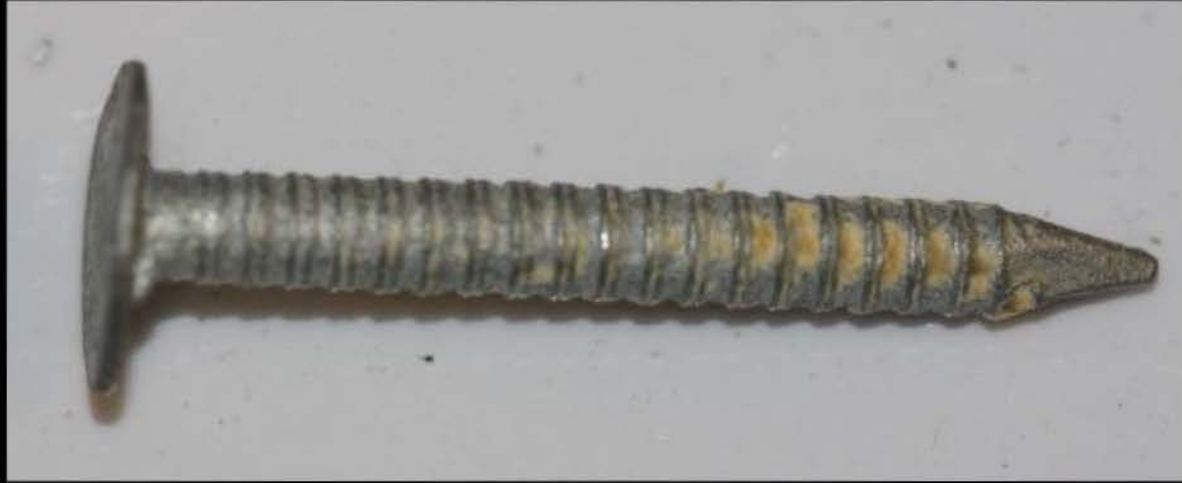
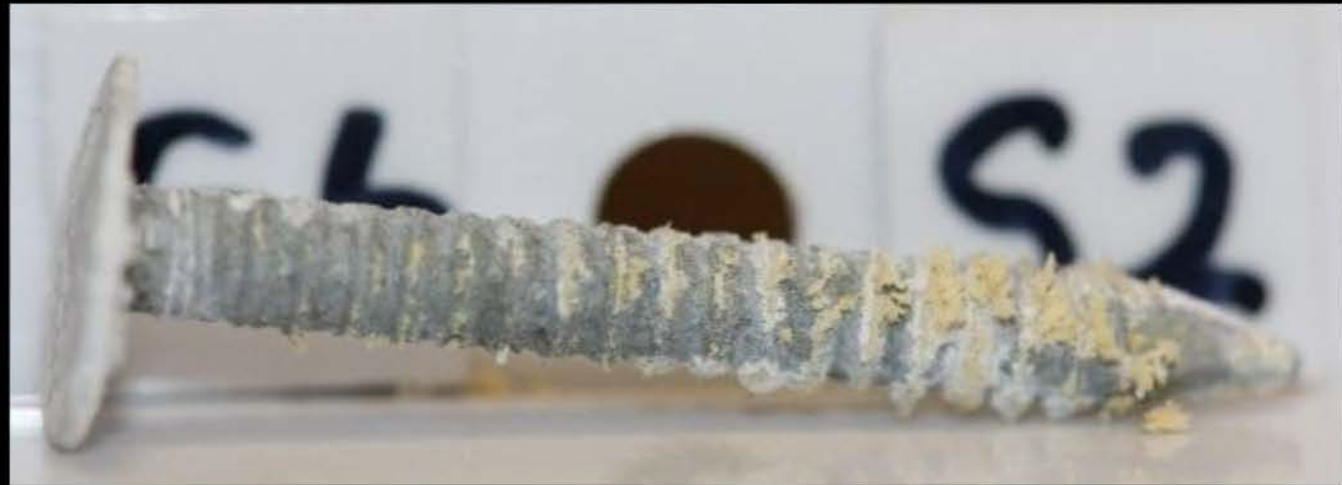
Test-2 hot dipped installed-removed

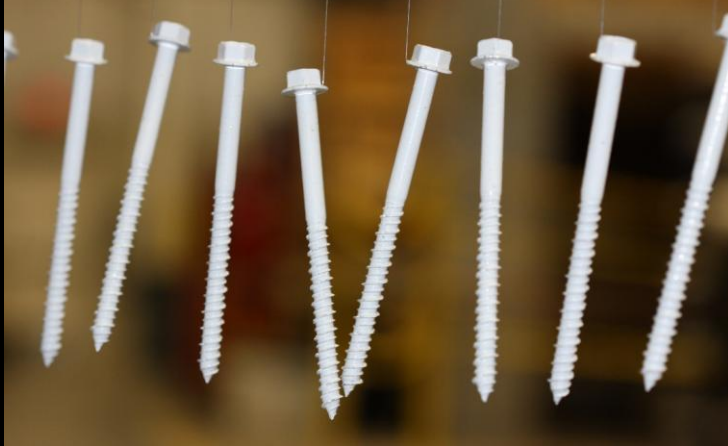
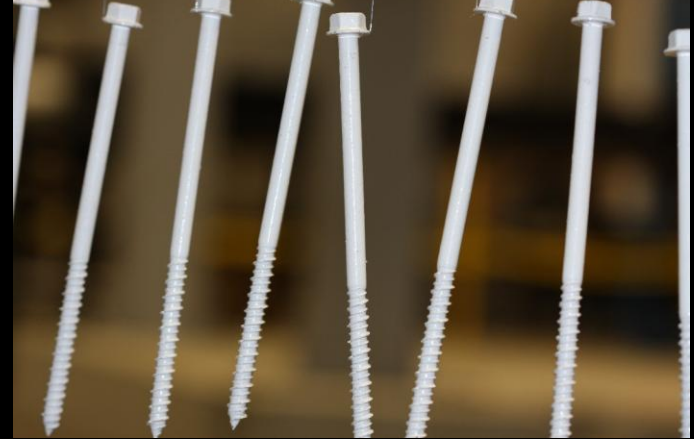
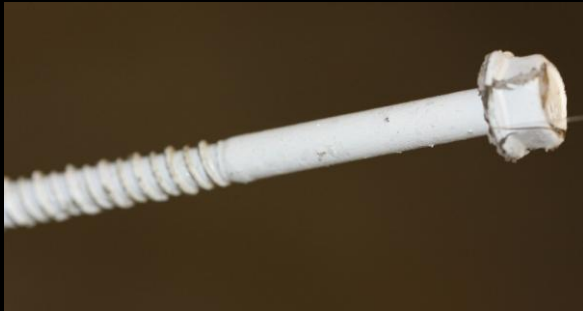
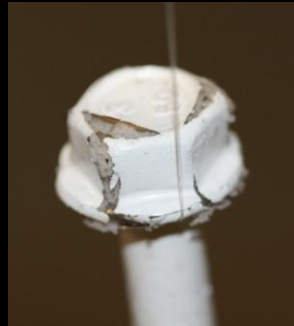
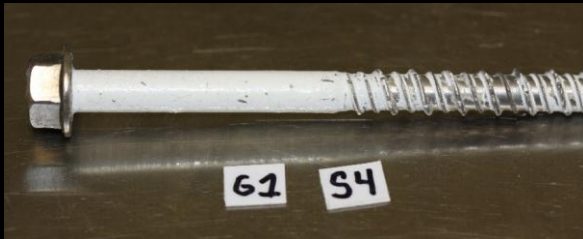
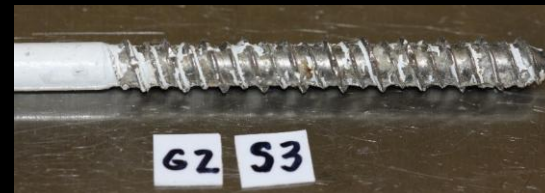
Test-3: 304 stainless: ceramic coated

- Testing completed last week (1000 hours)
- Scoring not yet completed
- Photos are provided to show typical performance

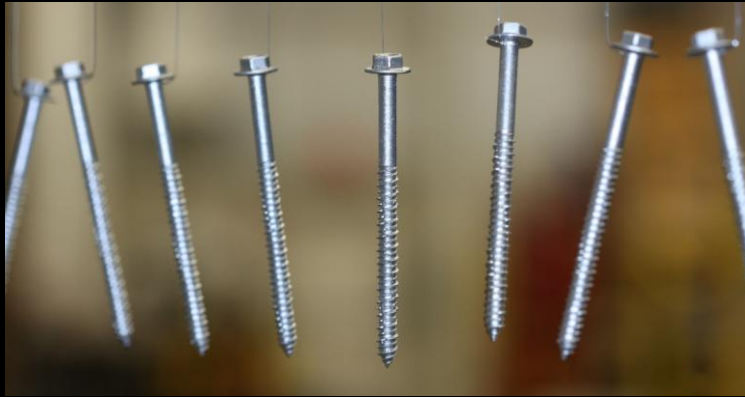
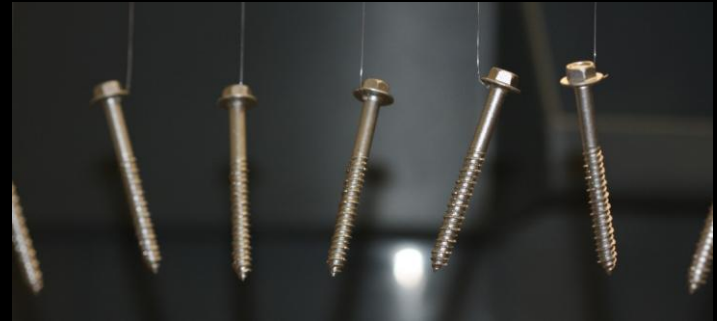
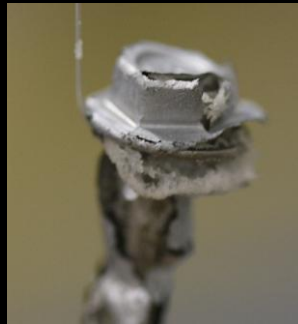
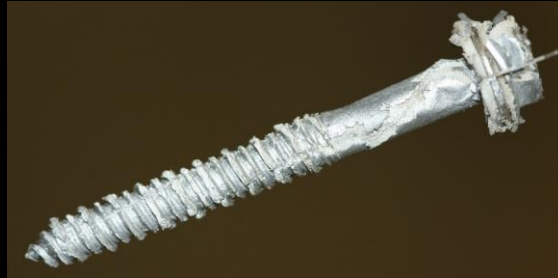
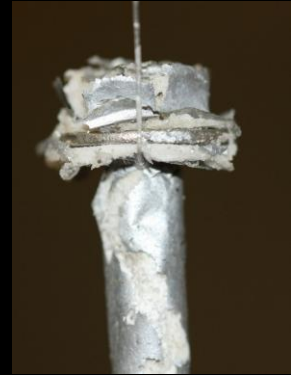
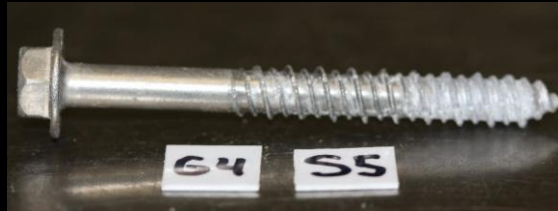
Test-3: 304 stainless: ceramic coated

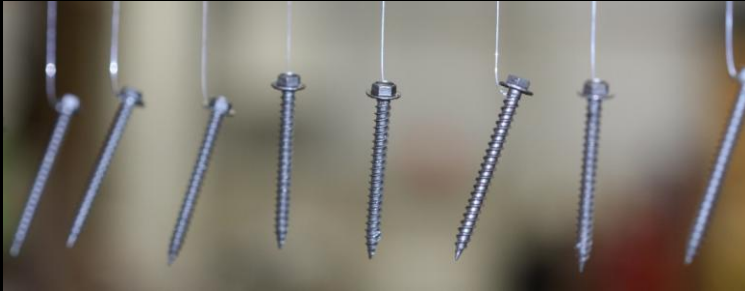
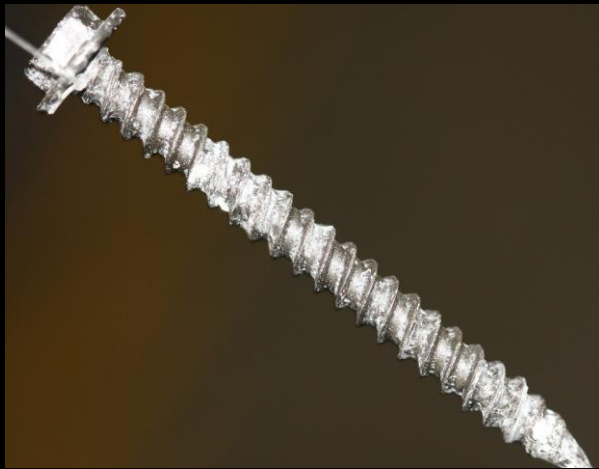
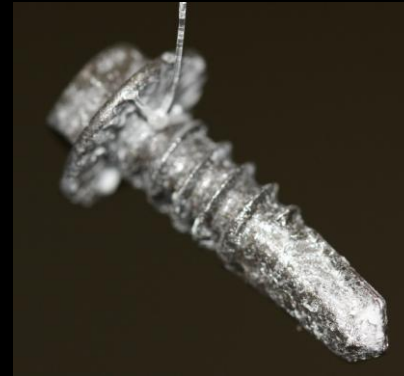
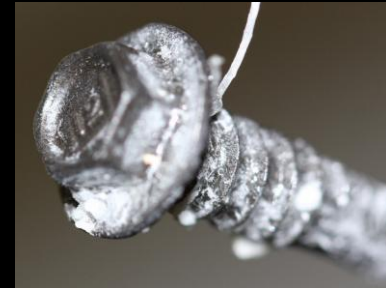
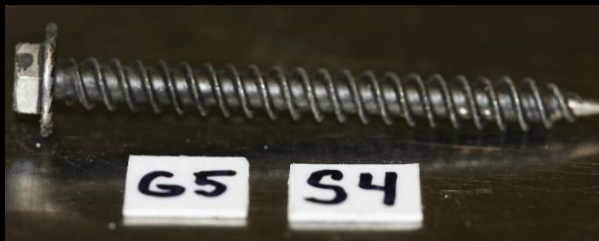
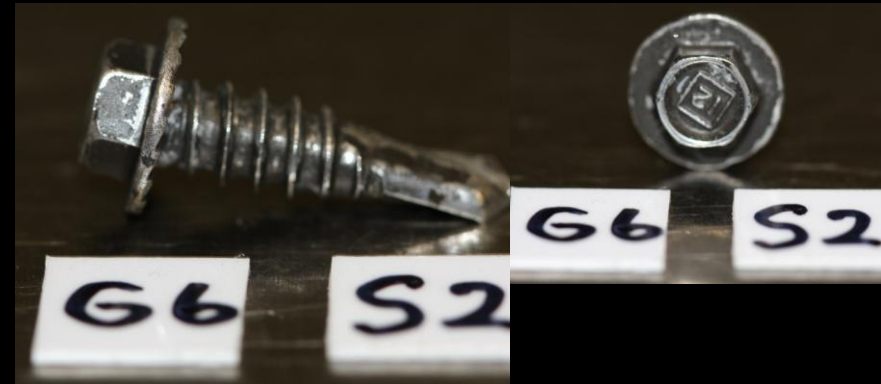
Test-3: 316 stainless: ceramic coated

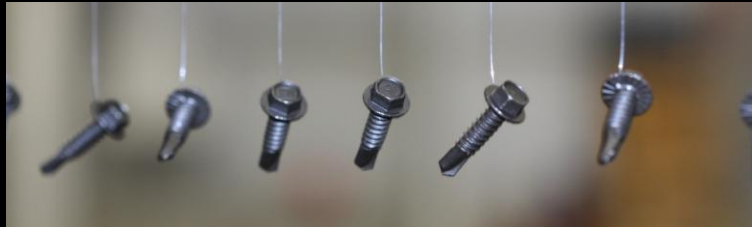
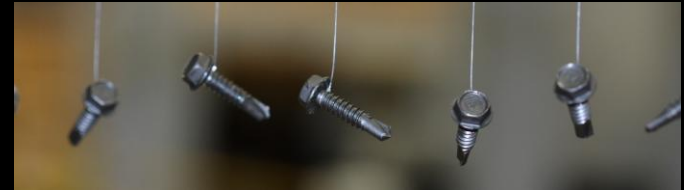
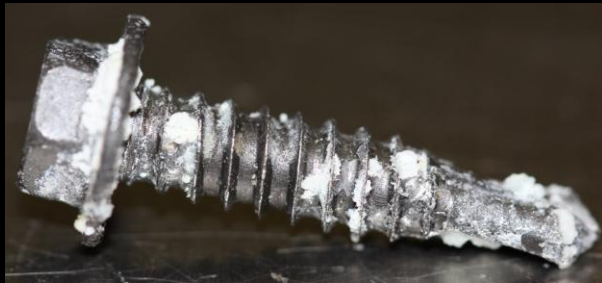
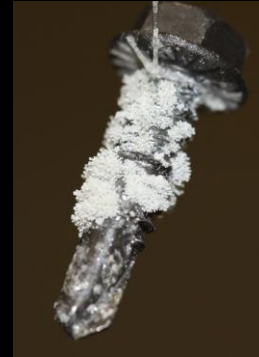
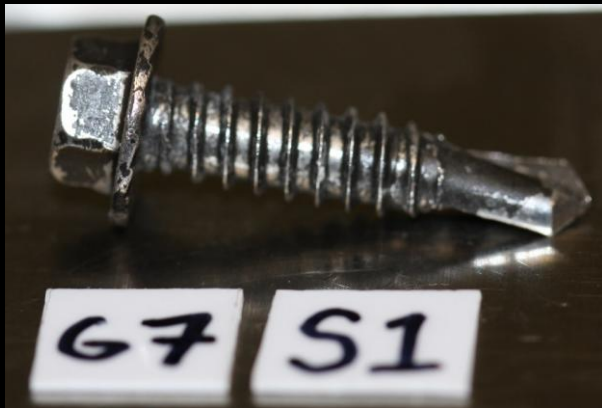
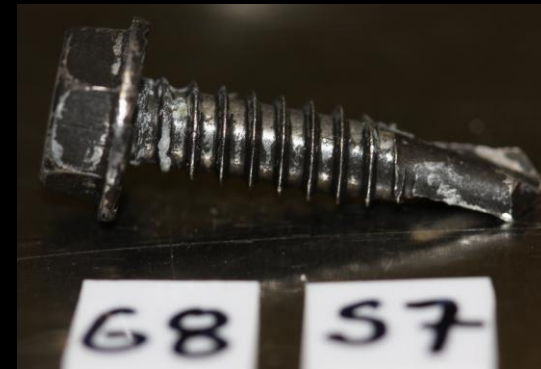
Test-3: 316 stainless: ceramic coated
