Corrosion of Roofing Fastener Systems

Draft Final Report

June 14, 2016

University of Florida

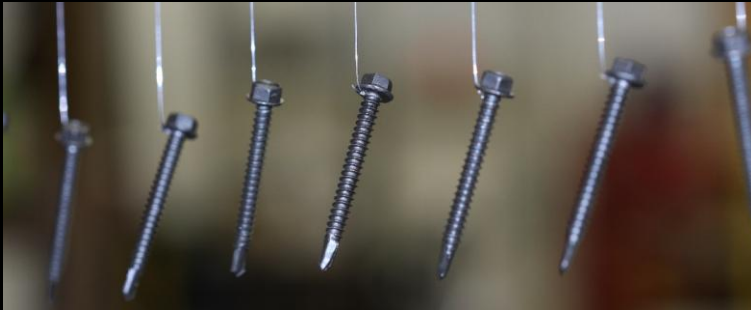
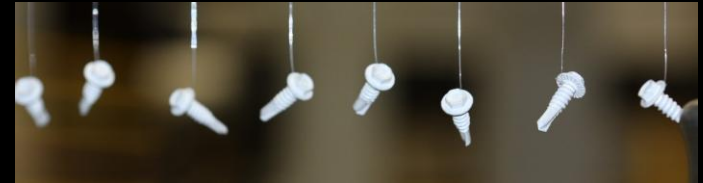
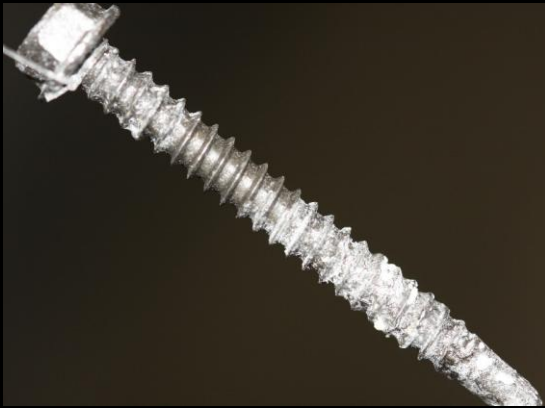
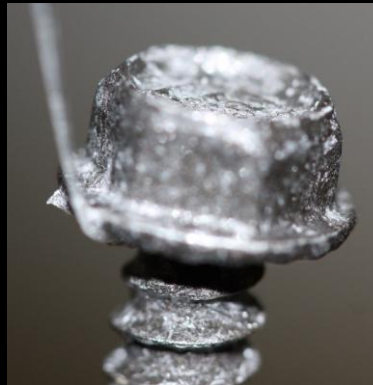
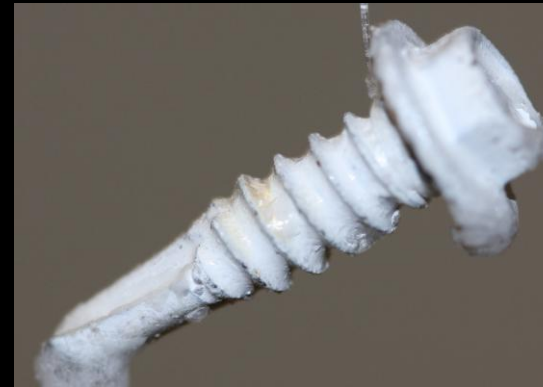
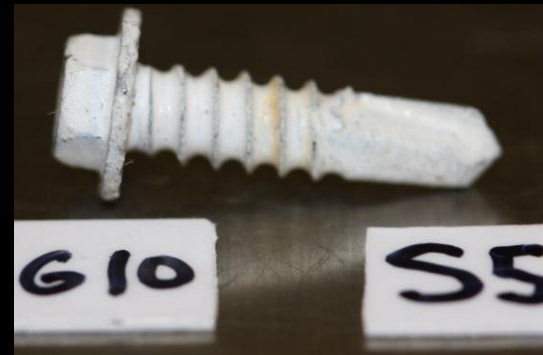
Test-3: 316 stainless: ceramic coated

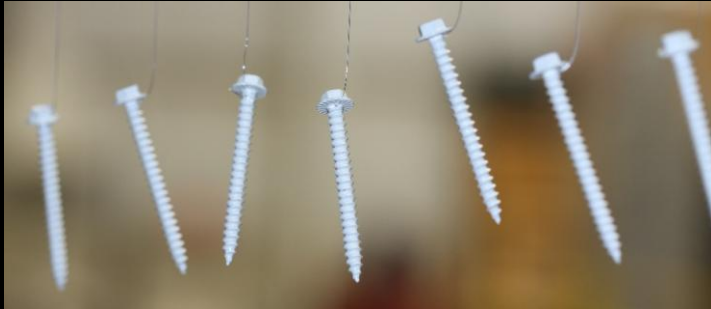
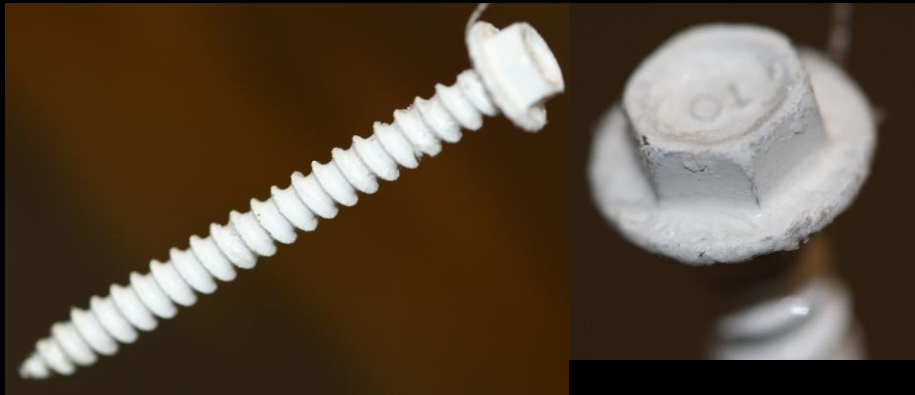
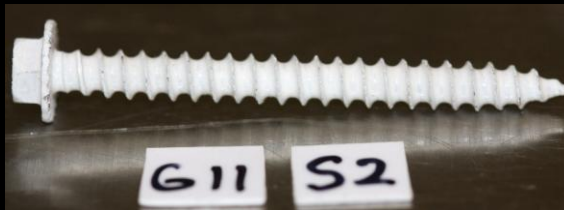
Test-3: 316 stainless: ceramic coated

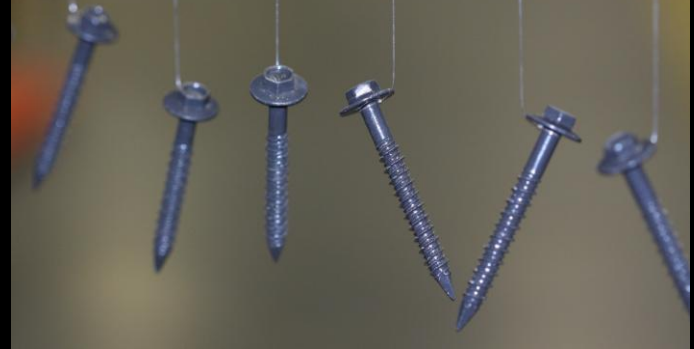
Test-3: unmarked
