Draft Final Report for Project Entitled:

Corrosion of Roofing Fasteners

June 1, 2016

Florida Building Commission
State of Florida Department of Business and Professional Regulation

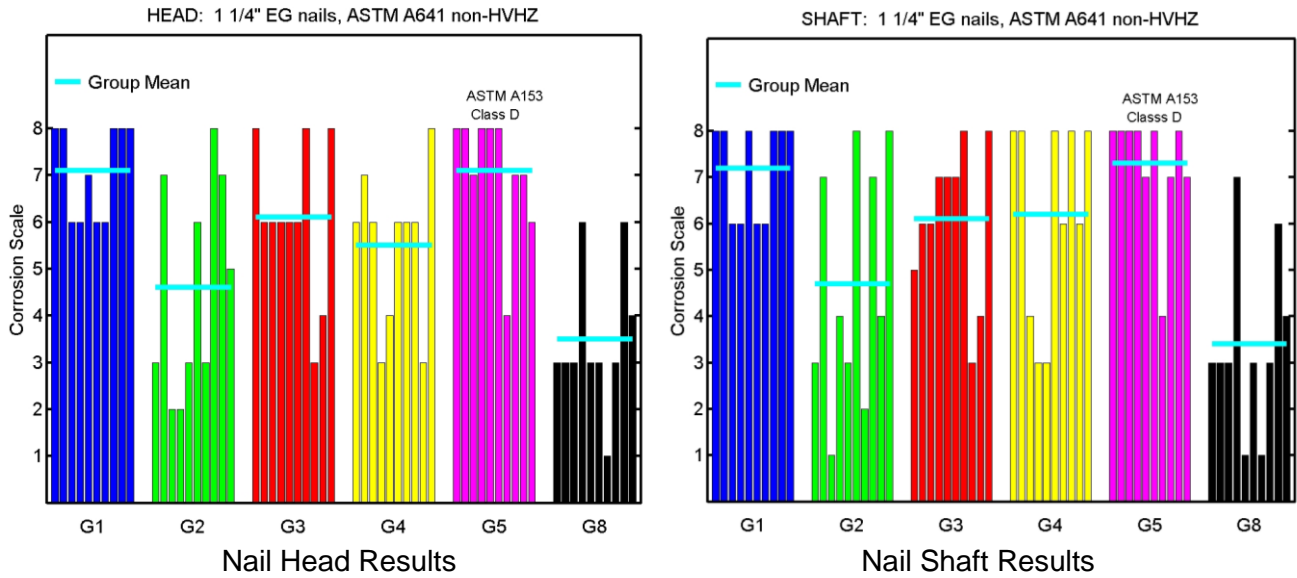
Figure 1: Test-1 Corrosion scale results for 1 ¼" EG nails, not HVHZ compliant.

- Figure 1: Electrogalvanized fasteners that are marked as ASTM A641 compliant did not generally perform any better than those in the phase 2 2014-2015 study. Only the G8 specimen type (page 17) demonstrated a consistent resistance to corrosion, where the predominant result was partial light surface corrosion. The other specimen types (G1 through G5, pages 11-15) resulted in at least half, more typically all, samples with heavy corrosion.

- Figure 1: The electrogalvanized fastener marked as ASTM A153 Class D compliant should have a thicker zinc coating than ASTM A641 compliant fasteners. However, specimen type G5 (page 15) was among the worst performers.

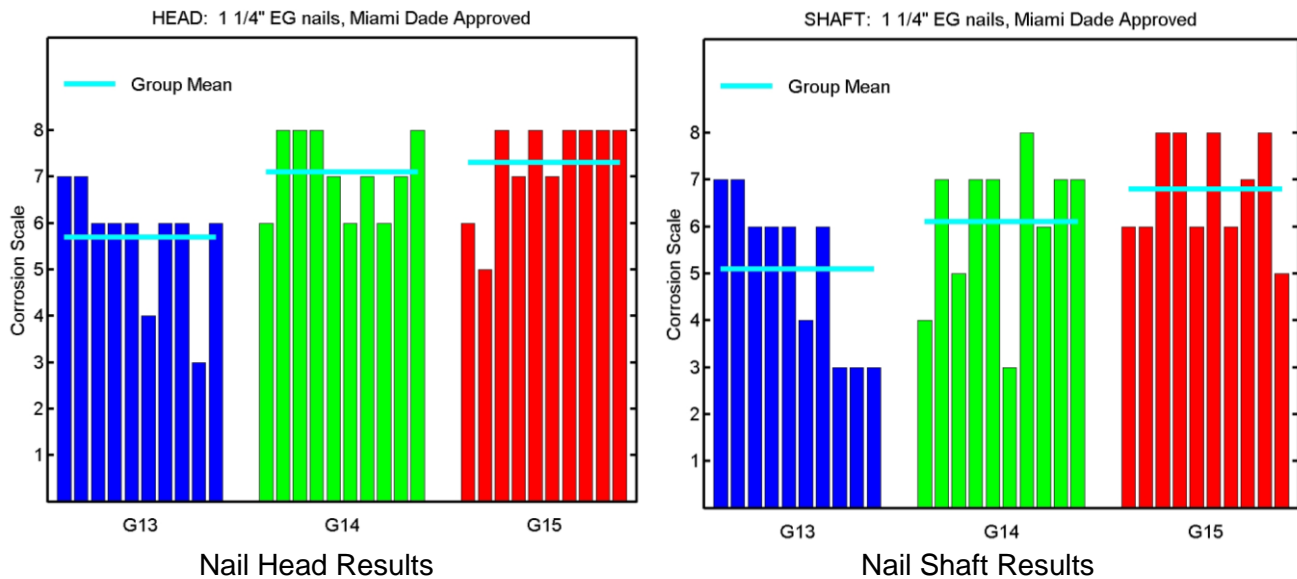
Figure 2: Test-1 Corrosion scale results for 1 ¼" EG nails, HVHZ compliant.

- Figure 2: Electrogalvanized fasteners that are marked as Miami-Dade compliant show no better performance than the ASTM A641 fasteners in Figure 1. Specimen types G13 through G15 (pages 20-22) had heavy corrosion in at least half of all samples.

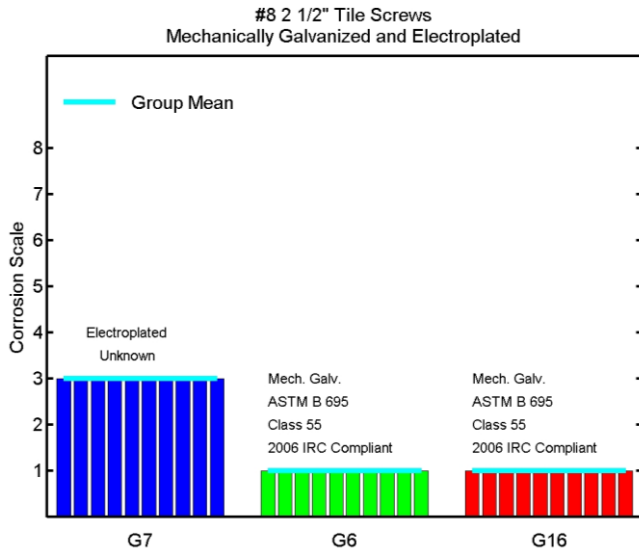
Figure 3: Test-1 Tile screws (head and shaft results identical)

- Figure 3: The mechanically galvanized roof tile fasteners (G6 and G16, pages 16 & 23) showed no sign of corrosion. The test was not run for the required 500 cycles.

- Figure 3: The electroplated roof tile fasteners (G7, page 16) showed only partial light corrosion in all samples tested. The test was not run for the required 500 cycles.

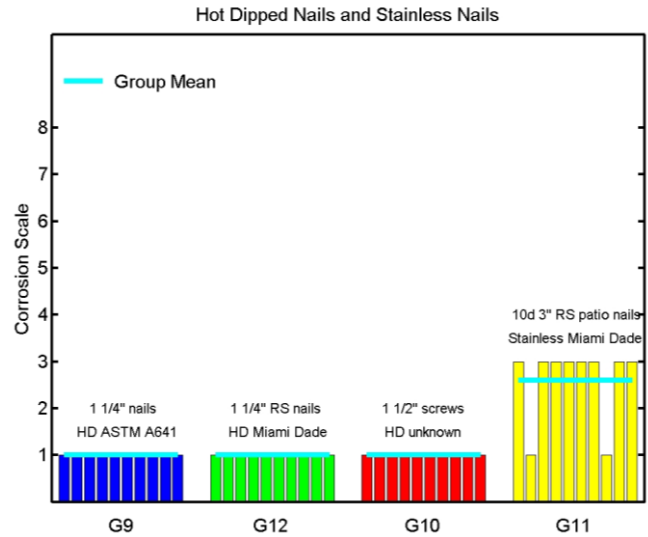
Figure 4: Test-1 Hot dipped and stainless steel (head shown, shaft results almost identical)

- Figure 4: The two hot dipped nail specimen types (G9 and G12, pages 18 & 19), and the one hot dipped screw specimen type (G10, page 18) showed no corrosion.

- Figure 4: The stainless steel ring shank patio/deck nail specimen type (G11, page 19) showed partial light corrosion on the shaft, and very light to no corrosion on the head.

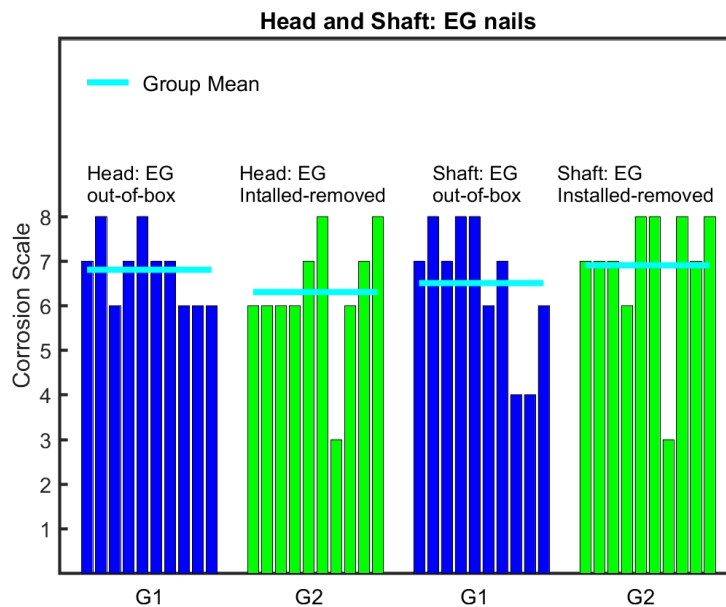
Figure 5: Test-2 Corrosion scale results for 1 ¼” EG nails, no certification marking. Blue: tested out-of-the-box. Green: installed-removed prior to testing

- Figure 5: Results are consistent with those of test-1 EG nails, demonstrating a high level of head and shaft corrosion. The process of installing and removing the fasteners did not improve or worsen the corrosion performance.

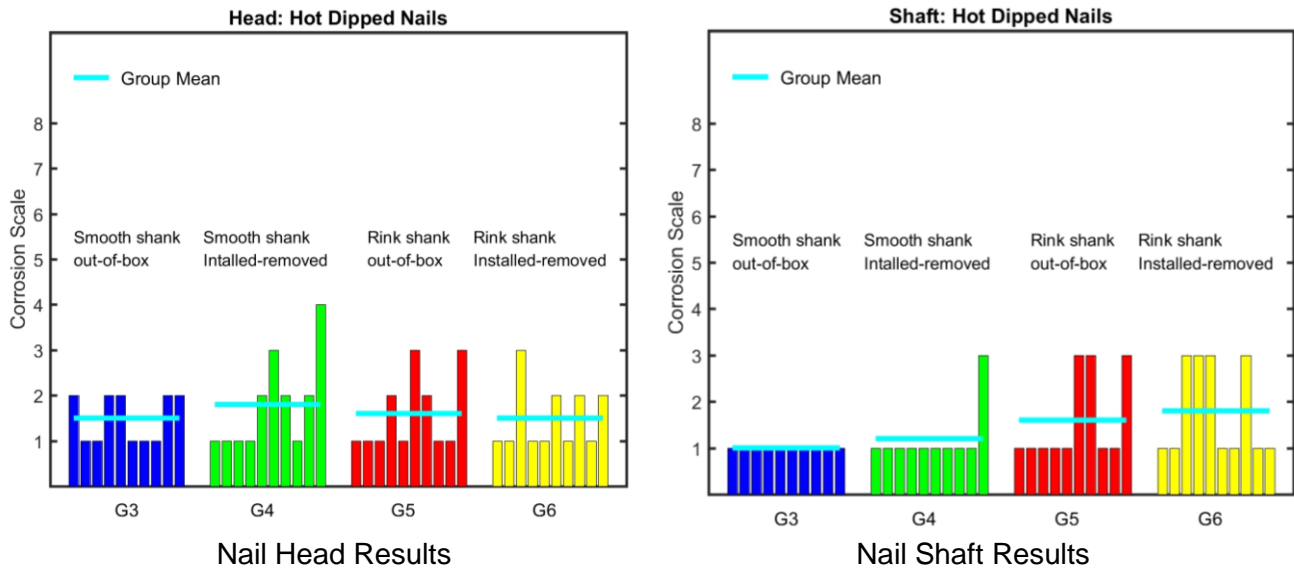
Figure 6: Test-2 Corrosion scale results for 1 ¼” Hot dipped nails, tested out-of-the-box and installed-removed as noted

- Figure 6: The two hot dipped nail specimen types tested out-of-the-box (G3 and G5) performed well, with a few samples showing very minor spots of corrosion on the head and shaft. Those two same specimen types tested after installation and removal (G4 and G6) also demonstrated good corrosion resistance. Those samples with a score of 2 had very minor corrosion on the edge of the head. Those samples with a score of 3 had only minor corrosion on a very small portion of the surface area. Note that a score of 2 does not apply to shaft results, as is specifically applies to the edge of the nail head. No significant difference between the corrosion resistance of installed-removed vs out-of-the-box tested nails was observed.

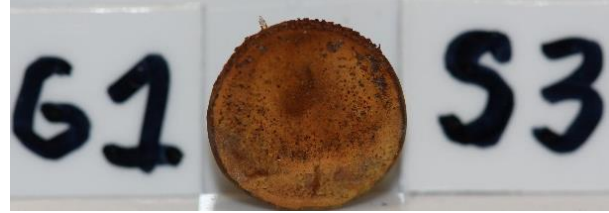
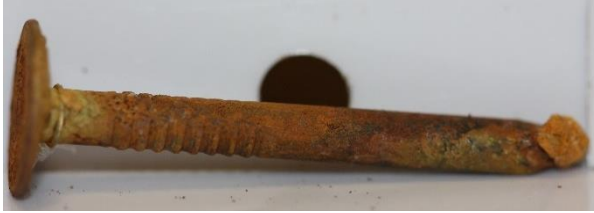
Sample 3 Head classification: 6	Sample 3 Shaft classification: 6

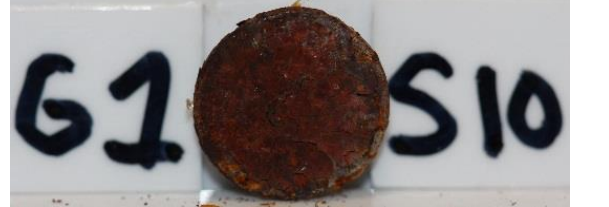
Sample 10 Head classification: 8	Sample 10 Shaft classification: 8

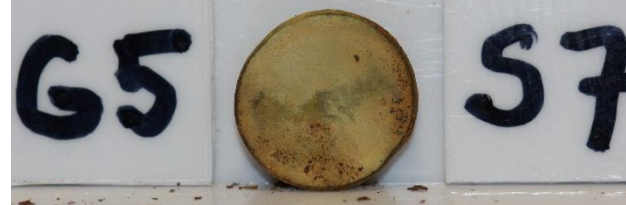
Sample 7 Head classification: 4	Sample 7 Shaft classification: 4

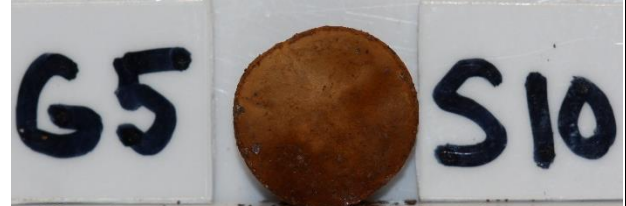
Sample 10 Head classification: 6	Sample 10 Shaft classification: 7

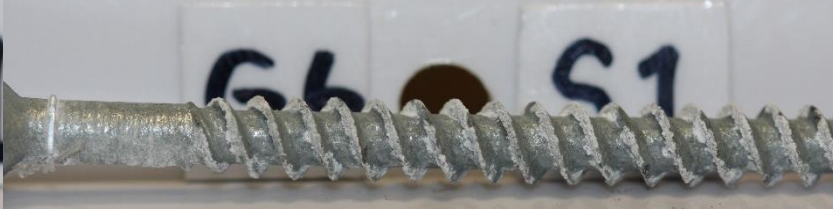
Sample 1 Head classification: 1	Sample 1 Shaft classification: 1

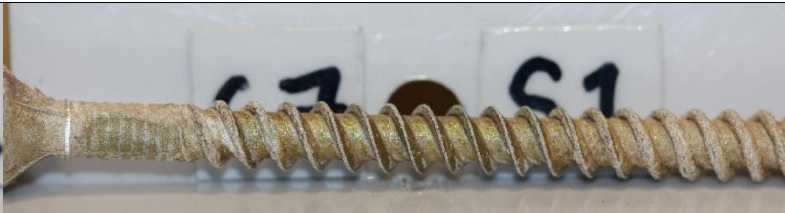
Sample 1 Head classification: 3	Sample 1 Shaft classification: 3

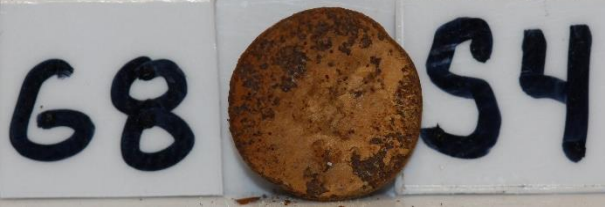
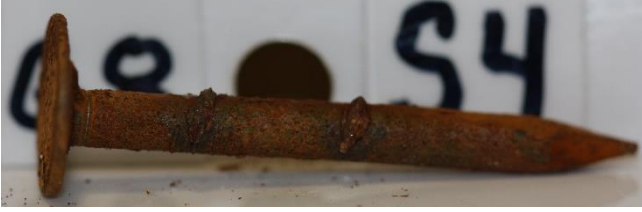
Sample 4 Head classification: 6	Sample 4 Shaft classification: 7

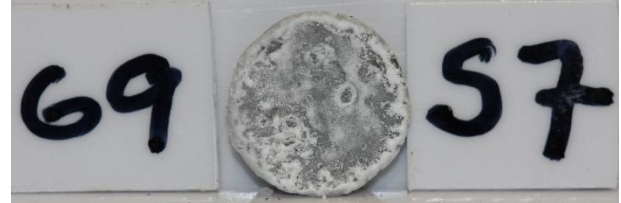
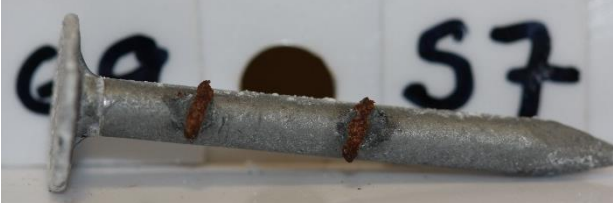
Sample 7 Head classification: 1	Sample 7 Shaft classification: 1

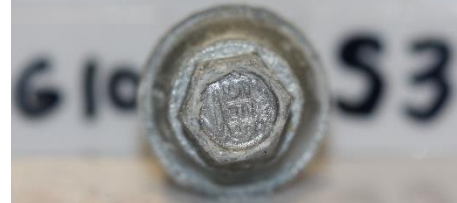
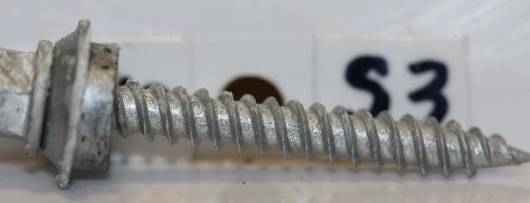
Sample 3 Head classification: 1	Sample 3 Shaft classification: 1

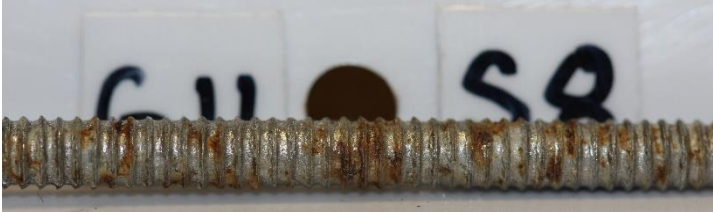
Sample 8 Head classification: 1	Sample 8 Shaft classification: 3

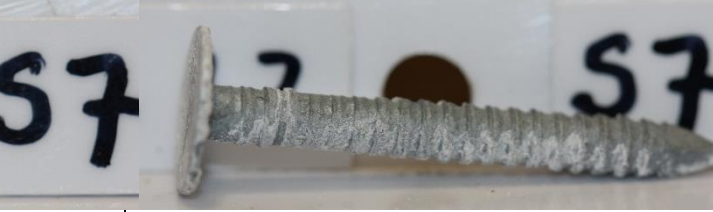
Sample 7 Head classification: 1	Sample 7 Shaft classification: 1

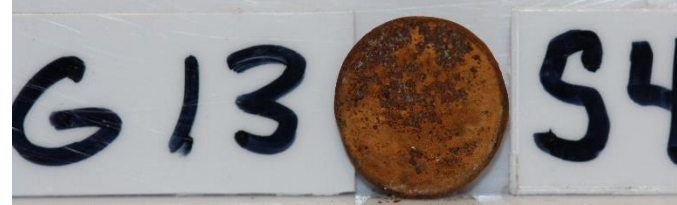
<p>Sample 4 Head classification: 6</p>	<p>Sample 4 Shaft classification: 6</p>

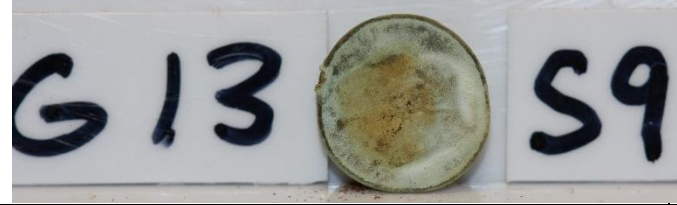
<p>Sample 9 Head classification: 3</p>	<p>Sample 9 Shaft classification: 3</p>

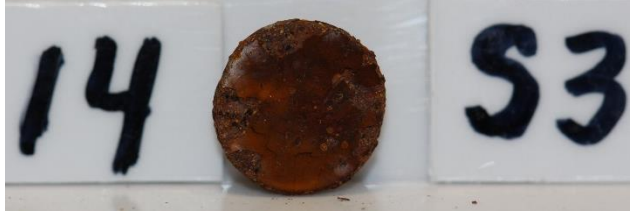
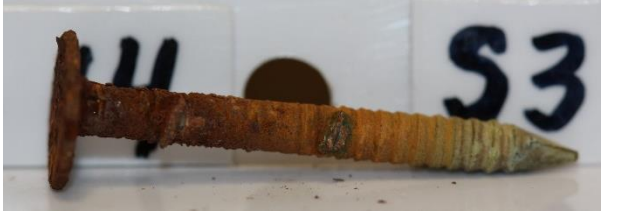
<p>Sample 3 Head classification: 8</p>	<p>Sample 3 Shaft classification: 5</p>

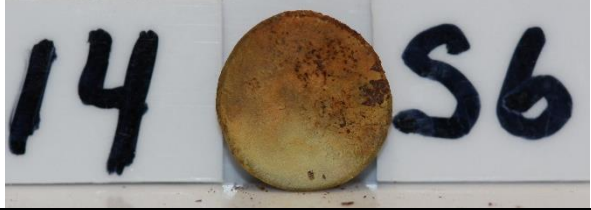
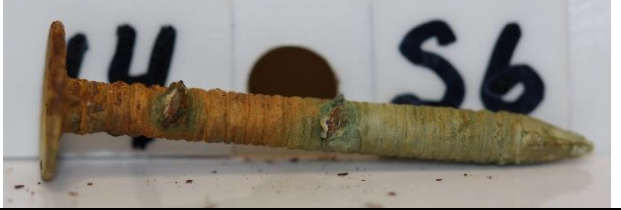
<p>Sample 6 Head classification: 6</p>	<p>Sample 6 Shaft classification: 3</p>

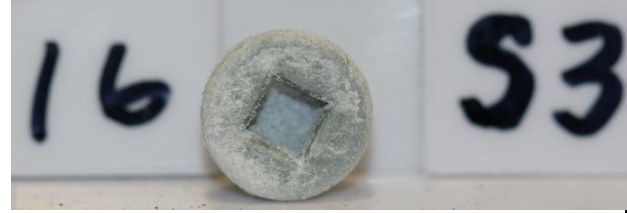
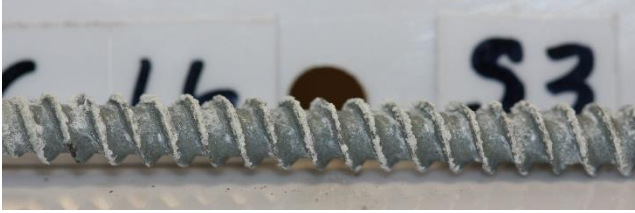
Sample 3 Head classification: 1	Sample 3 Shaft classification: 1

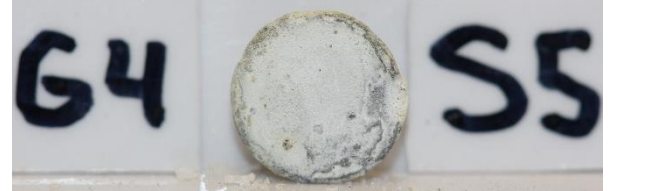
Sample 5 Head classification: 2	Sample 5 Shaft classification: 1

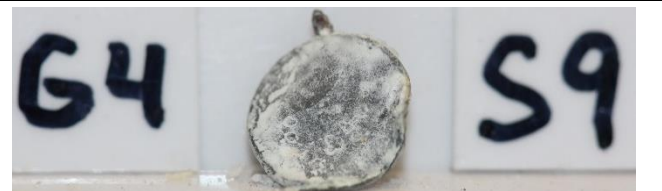
Sample 9 Head classification: 2	Sample 9 Shaft classification: 1

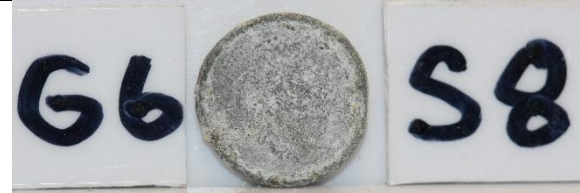
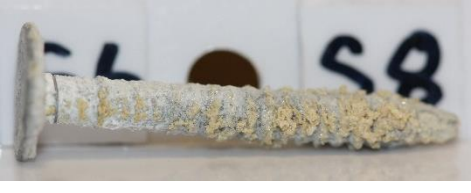
Sample 8 Head classification: 2	Sample 8 Shaft classification: 3

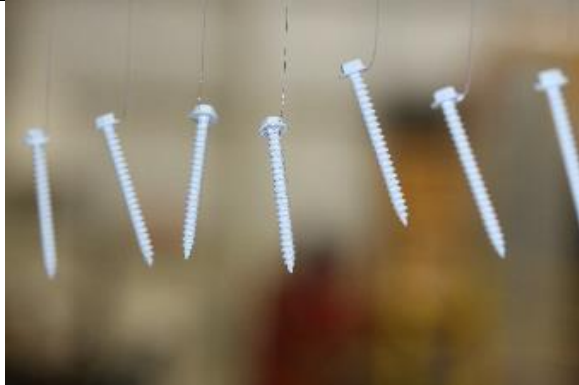
Group 11 pre-test

Group 11: Pre-test and after 765 hours of testing
Hex 1/4 10 x 2 SMS stainless white – Screen enclosure

Test-3 has not yet been completed. Therefore no scoring was conducted, as that process requires the removal of the specimens from the test chamber. Appendix C provides photographs of the specimens both prior to testing and after the completion of 765 out of 1000 hours. It can be observed that corrosion does not appear to be present on any specimens to date.
