A presentation to:

Palm Beach County Water Resources Task Force

By: Ed Weinberg, PWS

Avenir Conservation Area Regional Context

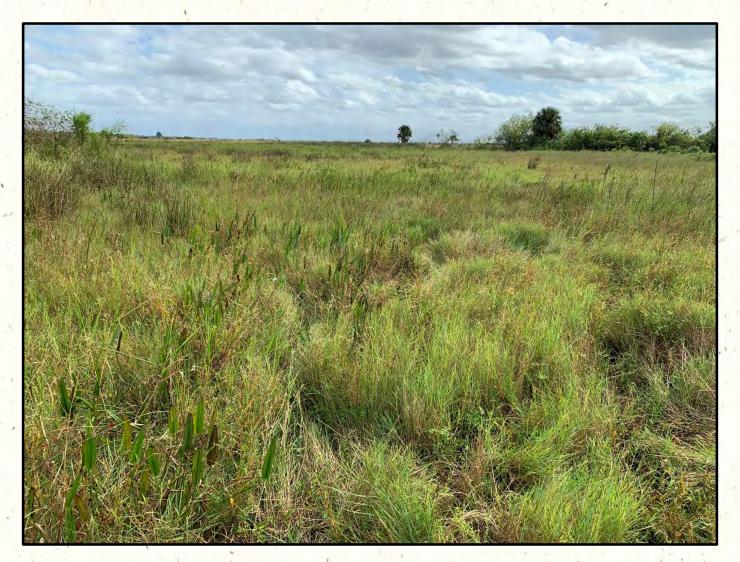
Existing Conditions – Wetlands - variety of invasive non-native species

Wetland conditions January 2019

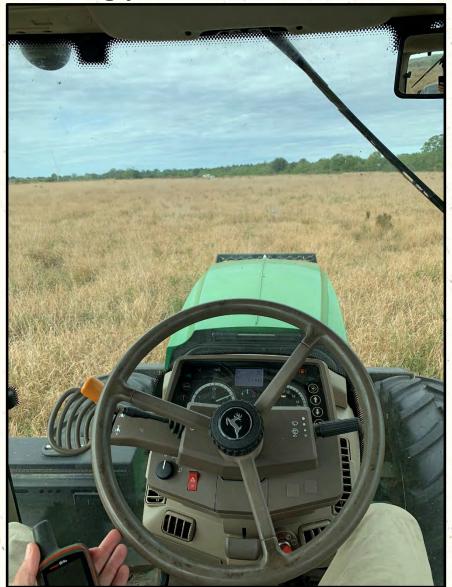
Step 1 – Mowing senescent above-ground biomass

Mowing process

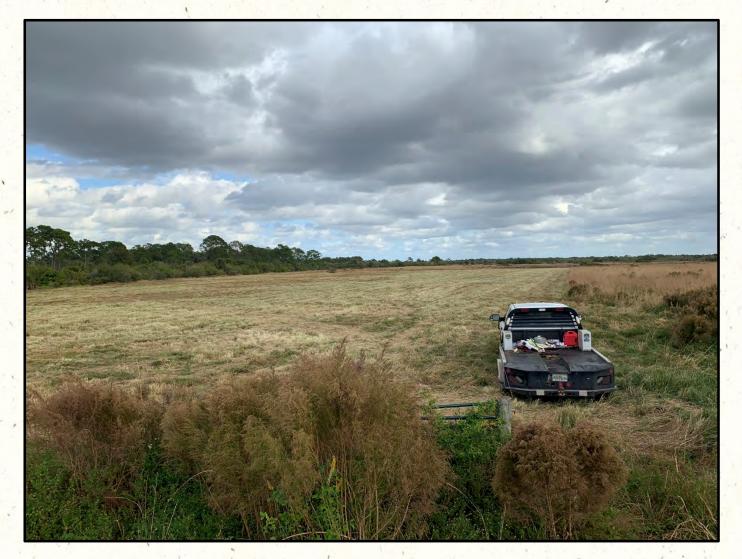
Completed Mowing

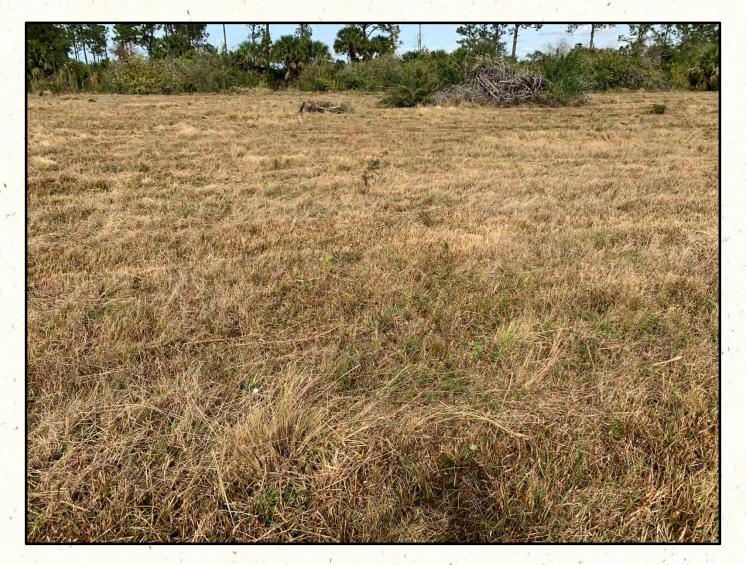
Completed Mowing close up

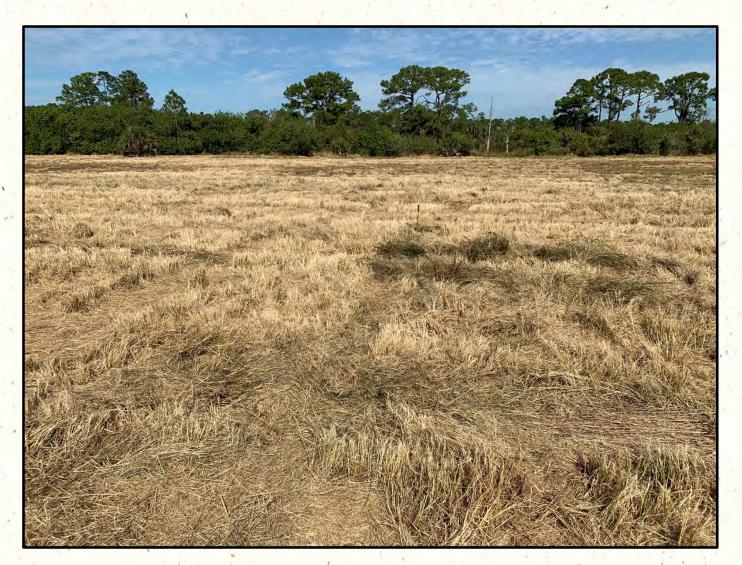
Glyphosate application to active growth after mowing

Tractor mounted spray rig application

Post Herbicide Treatment

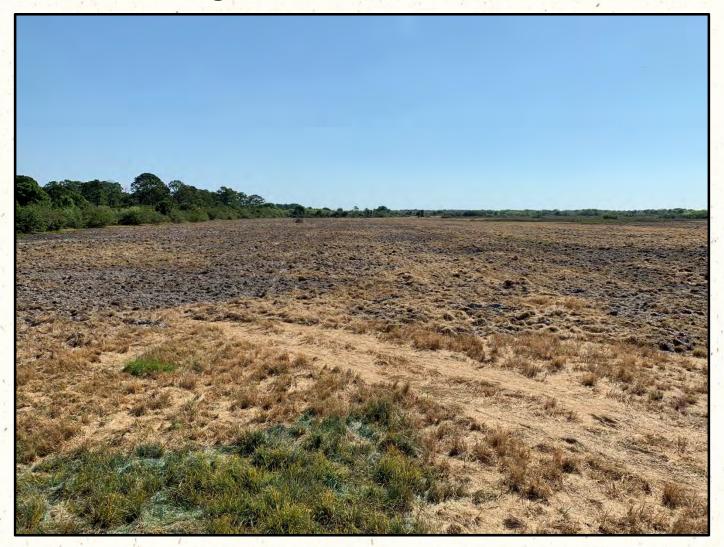
First run to break up rhizomes and existing vegetative material

First run disking March 2019

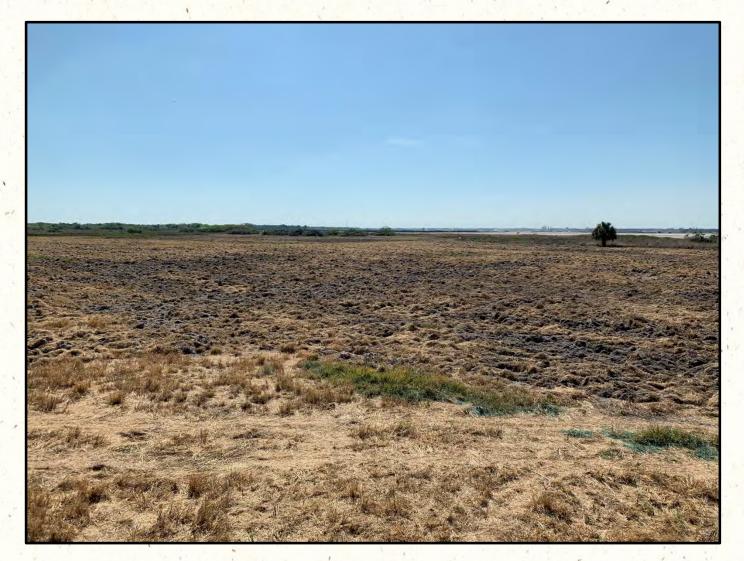
First run disking March 2019

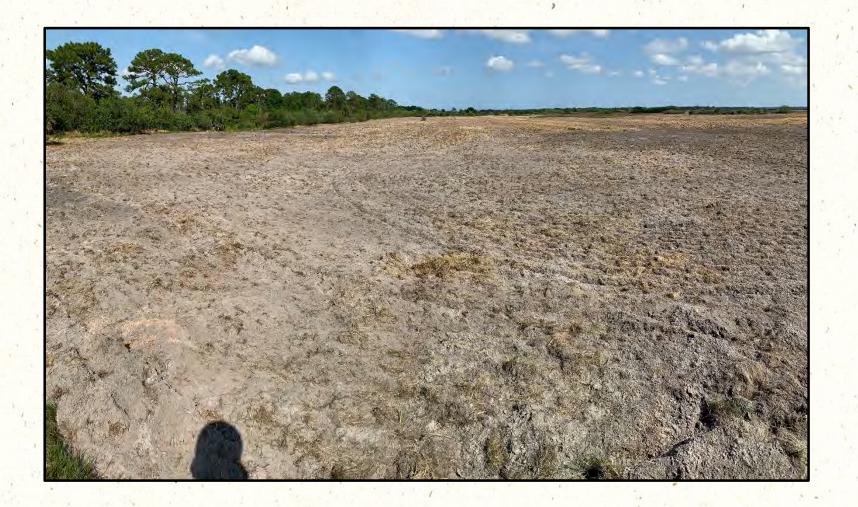
Second and third runs to expose soil

Second/third disking

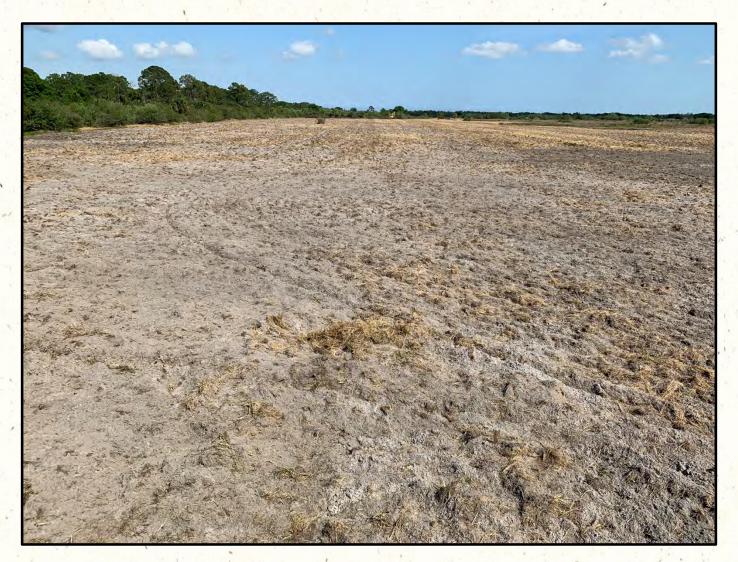
Second/third disking

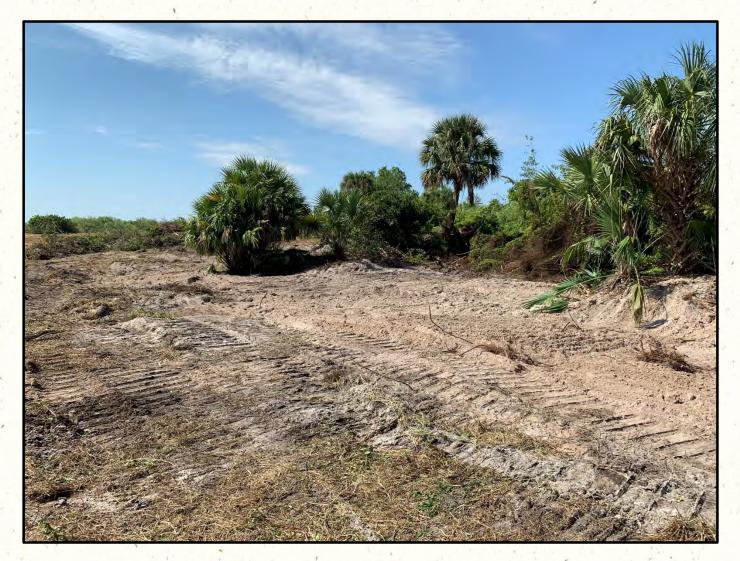
Heavy equipment removes above ground biomass and root system

Mechanical Removal of Brazilian pepper

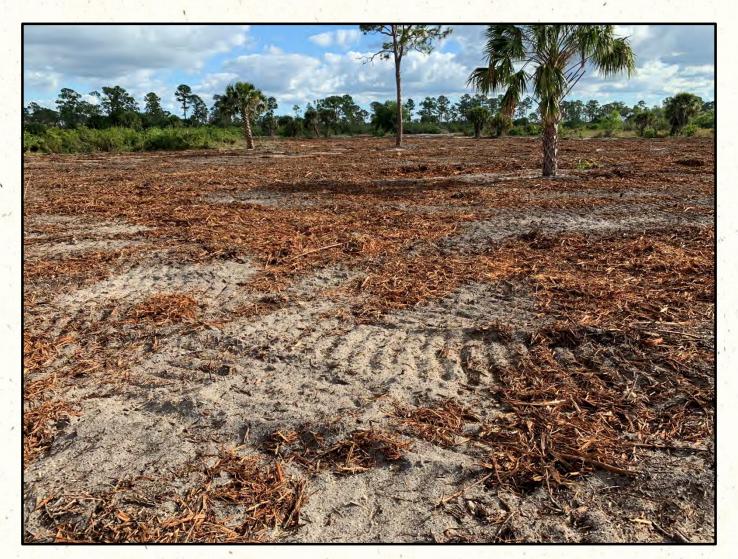
Mulch spread and disked into soil to add organic material

Mulch Spreading

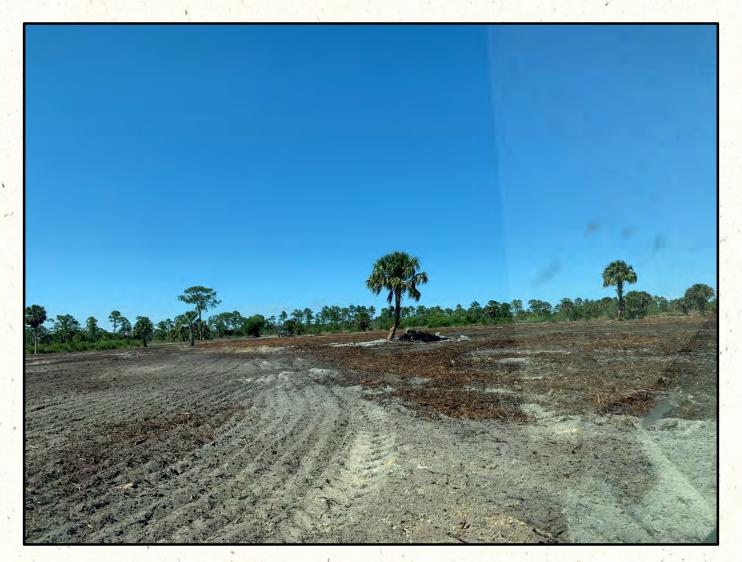
Disking in mulch

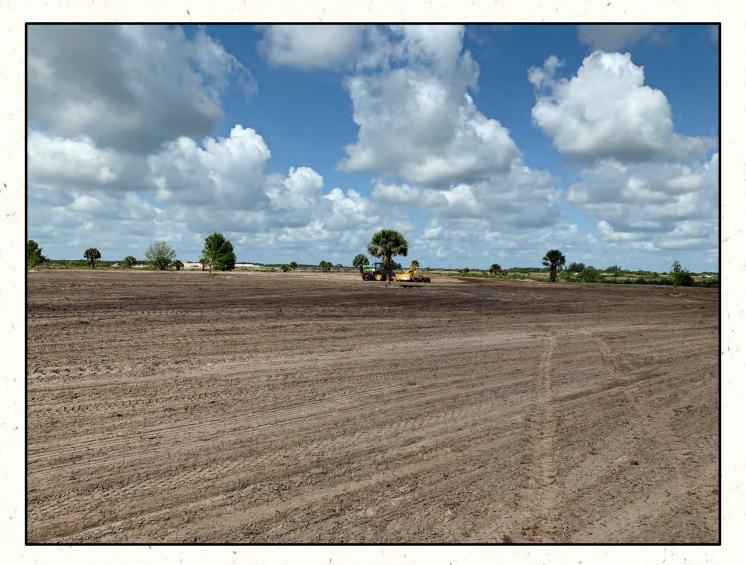
Laser/GPS guided agricultural leveling equipment

Leveling and equipment

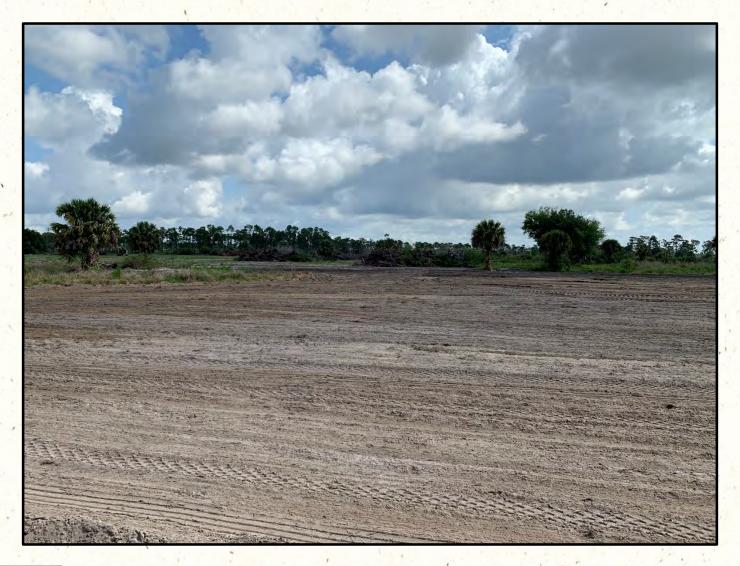
Leveled fields May 2019

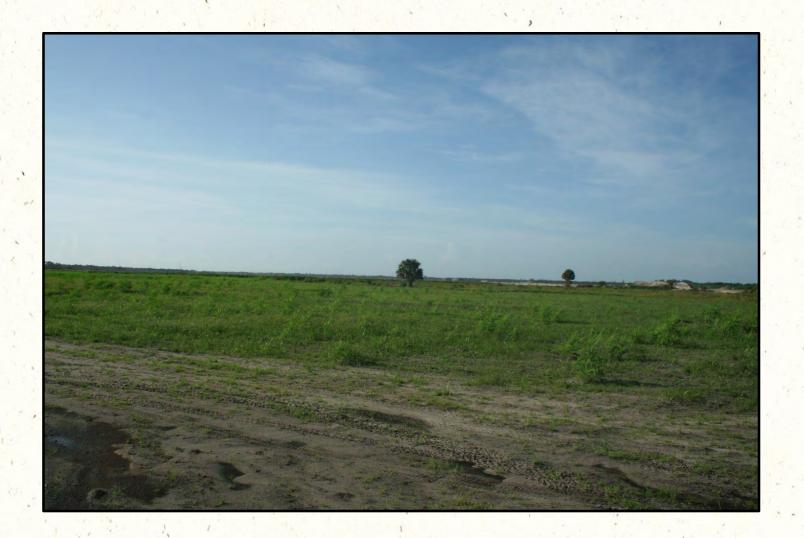
Vegetation recruitment June 2019

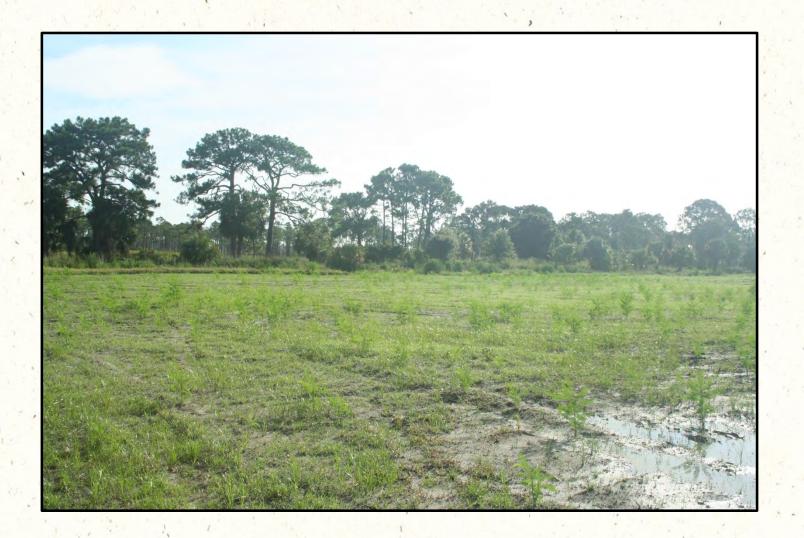
Vegetation recruitment June 2019

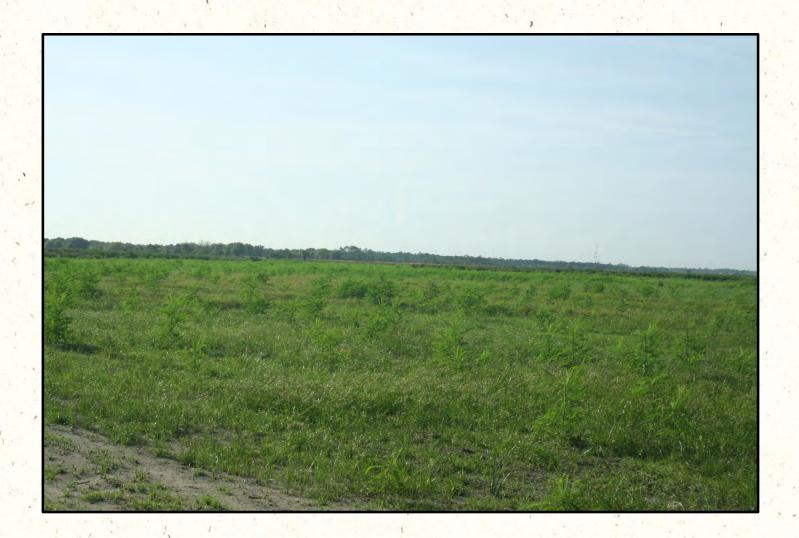
Vegetation recruitment July 2019

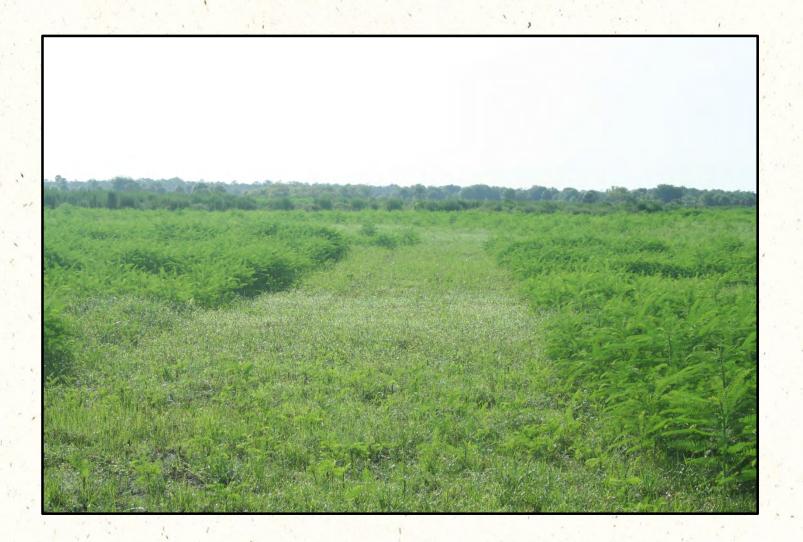
Intermittent mowing to facilitate diversity and "break out" for plantings

Mowing recruited vegetation

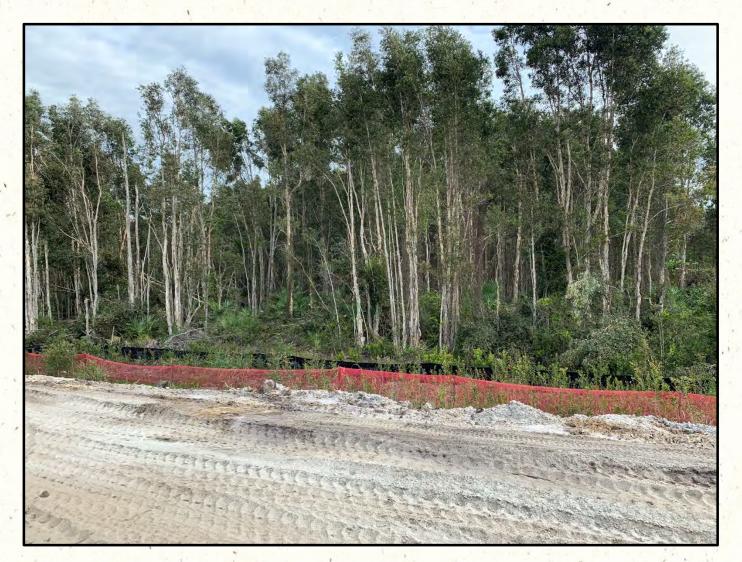
Melaleuca head at development boundary

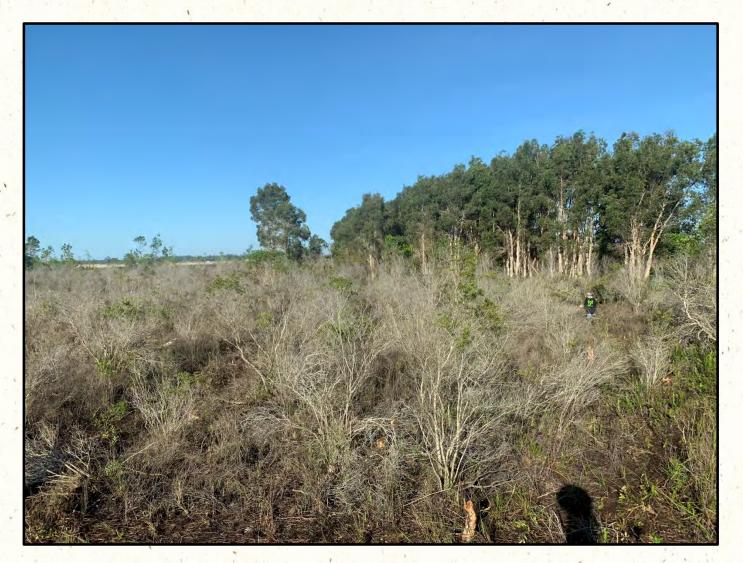
Melaleuca head within wetland

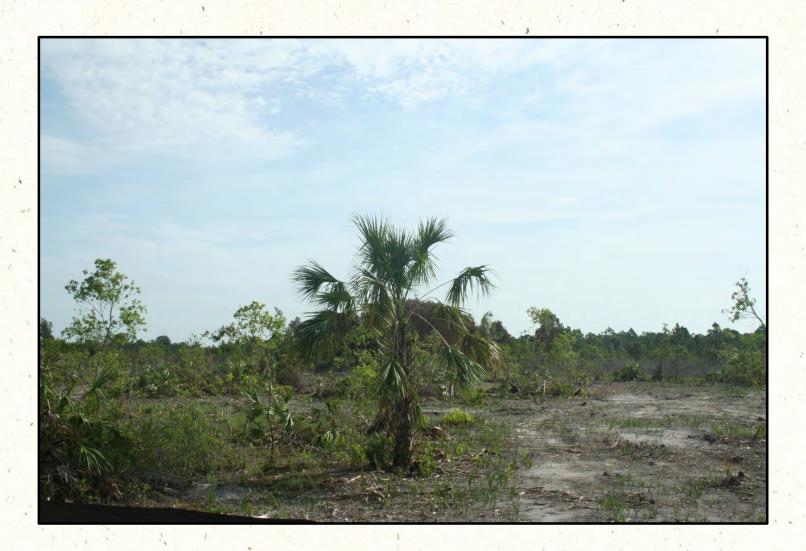
Melaleuca mechanically removed at boundary

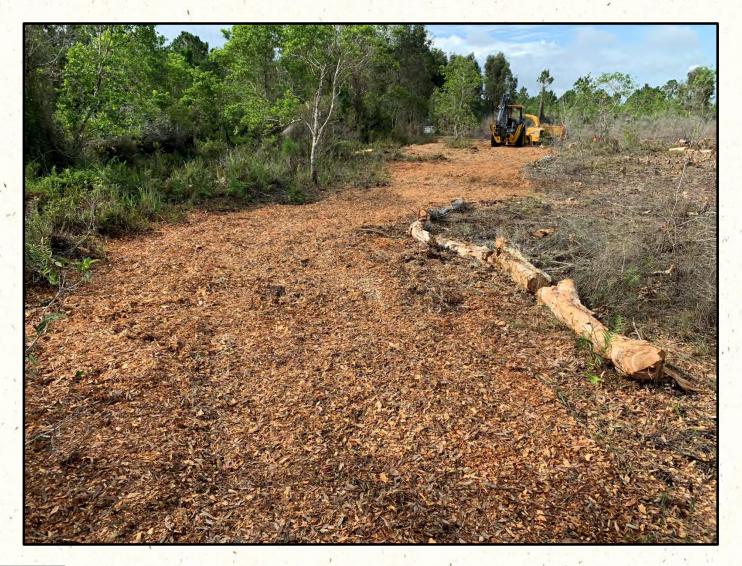
Melaleuca cut and mulched for trail

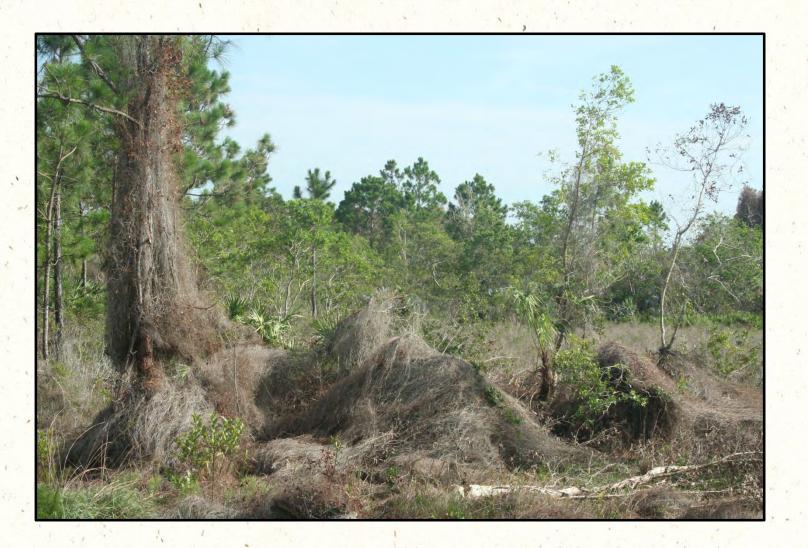
Old World climbing fern treatment

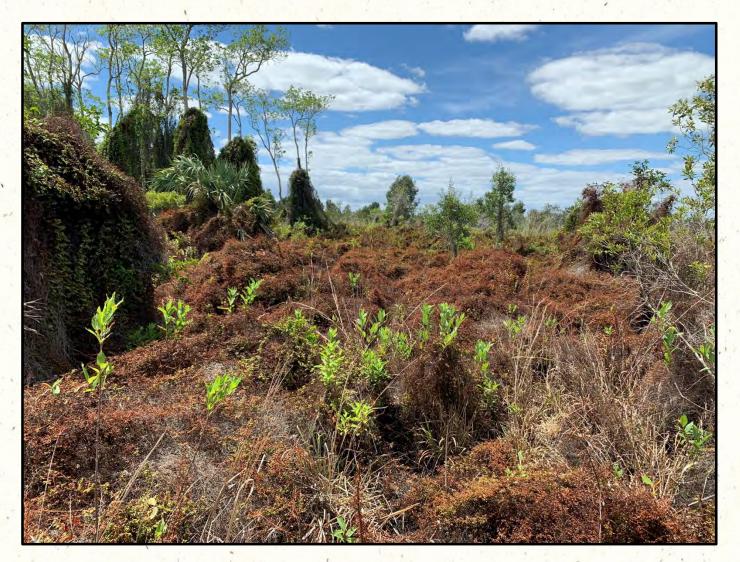
Old World climbing fern treatment
