Rainwater Management Performance of Newly Constructed Residential Building Enclosures During August and September 2004

Prepared for the Home Builders Association of Metro Orlando and the Florida Home Builders Association By:

January 11, 2005

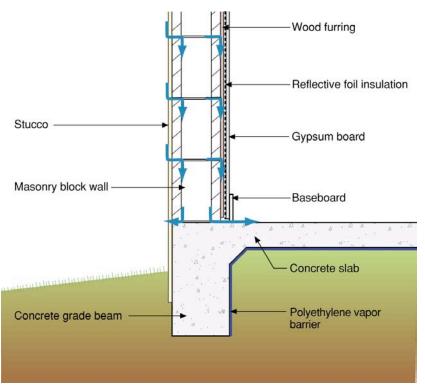
Figure 8: Rainwater Entry into Mass Assembly

The mass assemblies were overwhelmed due to the extraordinary weather events. The mass assemblies were not able store the quantity of penetrating water and not able to dry rapidly enough between wetting events and in many situations water entered past the interior lining (Figure 8).

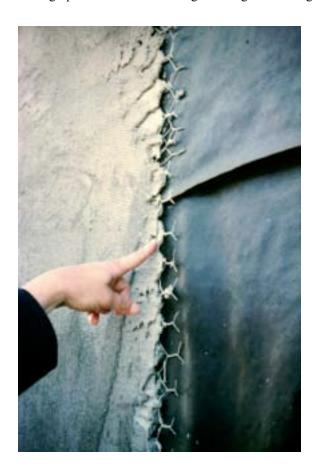
Photograph 3: Stucco Rendering Bonding to Building Paper

There appear to be significant performance issues with WRB's relating to manufacture, testing and approval. All plastic housewraps and some building papers tend to bond to stucco renderings thereby negating drainage (Photograph 3). Additionally, many plastic housewraps loose their water repellency (Figure 9) when in contact with sheathing and stucco renderings (Photograph 4).

The problem of adhesion of stucco renderings to plastic housewraps and to building papers can be address by installing a "bond break" (Figure 10). Tests showed that a thin layer of asphalt saturated felt acts as an effective bond break for both building papers (Photograph 10) and plastic housewraps (Photograph 11). The felt used is similar to the backing on paper backed lath (Photograph 12).

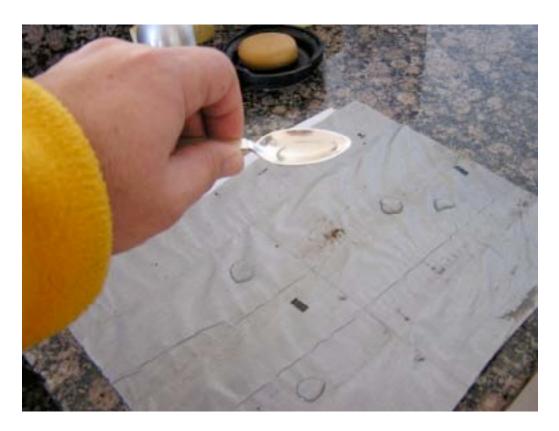
Photograph 5: Water Drop Test For Water Repellency

All perforated plastic housewraps fail a simple test for water repellency and water holdout (Photograph 5 and Photograph 6). Many non perforated housewraps fail a similar test when exposed to surfactants (Photograph 7, Photograph 8 and Photograph 9).

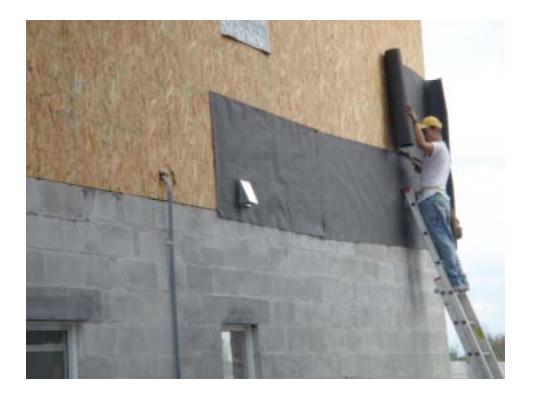
Photograph 14: Building Paper As Bridge Flashing

The typical method of installation is to extend the building paper downwards over the joint between the frame assembly and the mass assembly (Photograph 14). The building paper acts as a "bridge flashing" between the two assemblies.

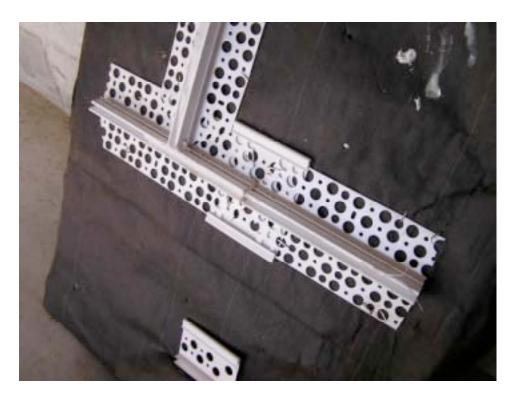
Photograph 15: Control Joint Accessories Installed Over Top of Drainage Plane

Control joint accessories are not typically designed as water shedding devices – i.e. "flashings" (Photograph 15). They are designed in most cases to be installed over the top of building paper rather than being "tucked" behind building paper in a "shingle" or water shedding fashion. Standard application has these control joint accessories installed over the top to the building paper "bridge flashing" (Photograph 16). This creates a "dam" and water is directed inwards.

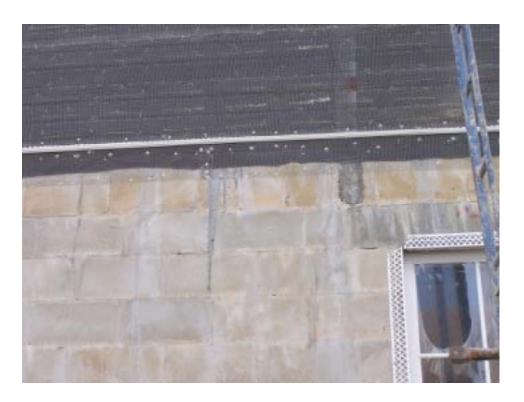
Photograph 16: Reverse Flashing Between Floors

This practice results in leaks during wind driven rain events (Photograph 17) as the moisture storage capacity of the frame wall assembly is easily overwhelmed in the absence of drainage. The second floor frame assembly, which is a drained assembly is effectively unable to drain anywhere except to the interior.

The appropriate practice is to use a flashing between floors that effectively drains the water to the exterior (Figure 12). This detail is described in detail in Photograph 18, Photograph 19, Photograph 20, Photograph 21 and Photograph 22.

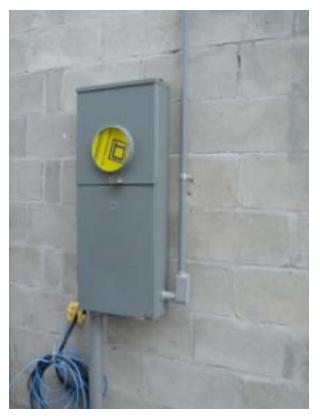
Photograph 31: Electrical Service Panel – No Water Control Behind Panel

Electrical panel boxes are typically installed without water protection behind them (Photograph 31). This is typically not a major issue as these panel boxes are located on garage walls. However, it is recommended that the stucco rendering be applied prior to the installation of the electrical panel box.

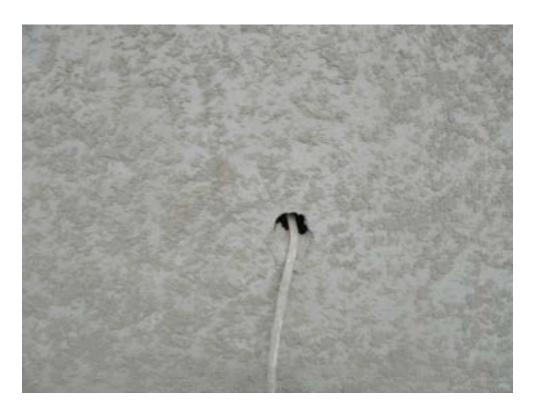
Photograph 32: Typical Maintenance Intensive Service Opening

Most openings rely on the application of sealant rather than a flashing approach to control rain entry (Photograph 32, Photograph 33 and Photograph 34). Sealants require maintenance.

Using a "flashing" approach to address service penetrations will provide improved performance (Photograph 35).

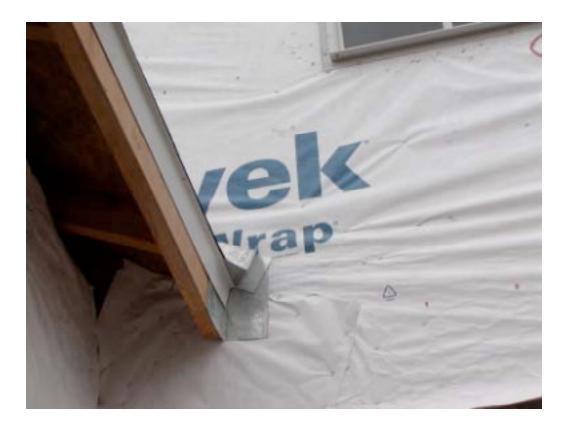
Photograph 38: Recommended KickOut Flashing Detail

Photograph 38, Photograph 39 and Photograph 40 illustrate effective "kick out" flashing construction.

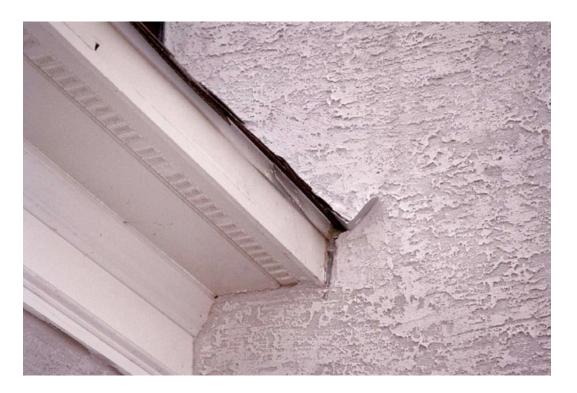
Photograph 39: Kick Out Flashing

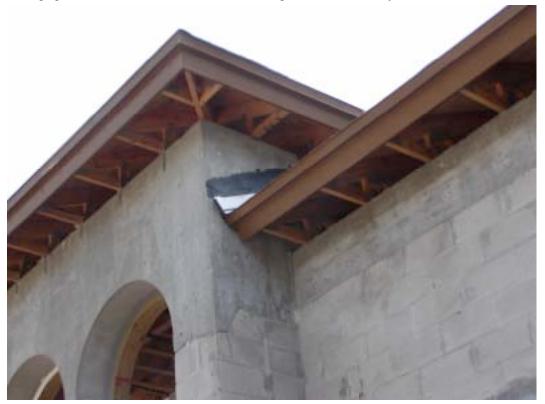
Photograph 40: Mastic Adhered Kick Out Flashing On Mass Assembly

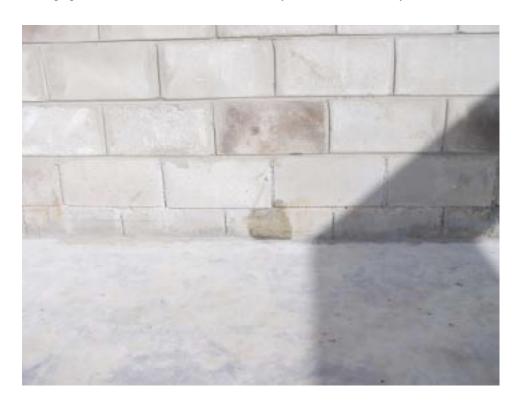
Photograph 55: Visual Indication of Water Entry At Base of Assembly

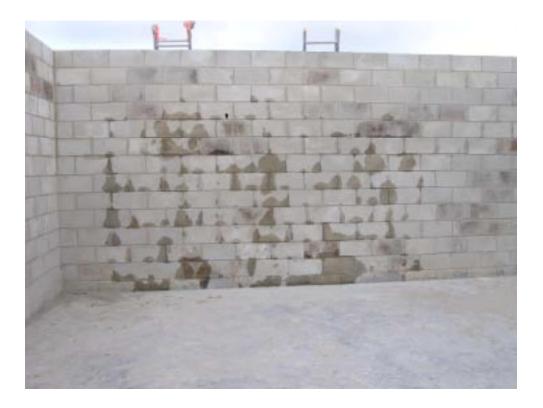
Photograph 56: Water Entry Pattern of Saturated Mass Assembly

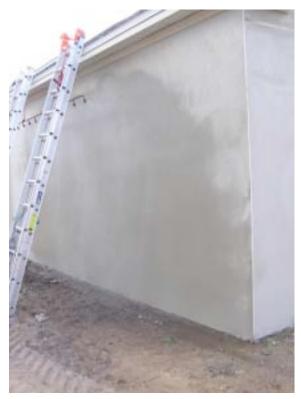
Three-hour water spray tests on unpainted walls systems rendered with stucco did not leak in the absence of cracks. To state the obvious, stucco without cracks does not leak – paint or no paint (Photograph 58 and Photograph 59).

Photograph 58: Three Hour Water Test – Unpainted Stucco Rendering

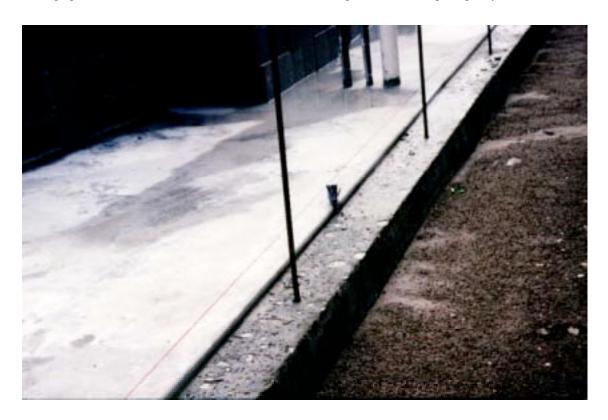
Increasing the moisture storage capacity of mass assemblies can partially address this issue. One approach is to construct a "seat" in the perimeter slab foundation to provide a reservoir for penetrating rainwater and to direct this rainwater to the exterior (Figure 20, Figure 21 and Photograph 62).

Photograph 62: Seat In Concrete Slab Foundation Increasing Moisture Storage Capacity

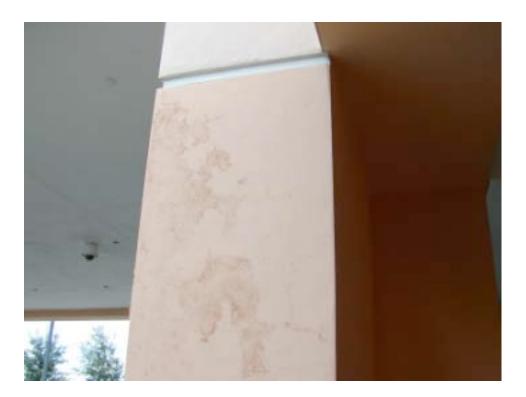
The experience with high build paint systems – such as "elastomeric paints" can lead to blistering (Photograph 63) and re-emulsification of additives. The use of such coatings should remain a specialty technique specified and supervised by professionals.

Photograph 63: Blistering of Elastomeric Paint Coating

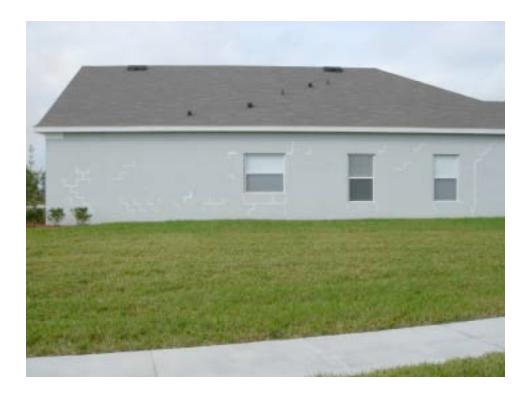
Low build and high build paint system on both smooth and textured surfaces were carefully examined (Photograph 66, Photograph 67 and Photograph 68) and it is our conclusion that almost no coating or painting system is able to span settlement cracks (Photograph 69). Only small hairline cracks on relatively smooth, and relatively untextured surfaces are there likely to be significant performance benefits of high build systems.

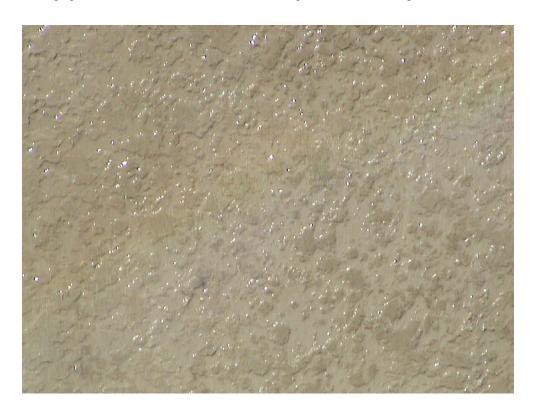
Photograph 70: Fiber Reinforced Stucco Rendering to Control Cracking

A more promising approach appears to lie with fiber reinforcement to control cracking and premium polymer modified and polymer based cementitious renderings (Photograph 70).

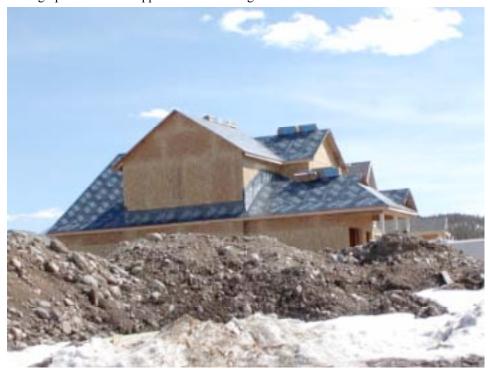
Self-adhering membranes that are directly adhered to structural decks such as plywood and OSB sheathing are a proven technology in all climate zones in the United States (Photograph 71, Photograph 72, Photograph 73 and Photograph 74).

Photograph 72: Direct Applied Self Adhering Membrane

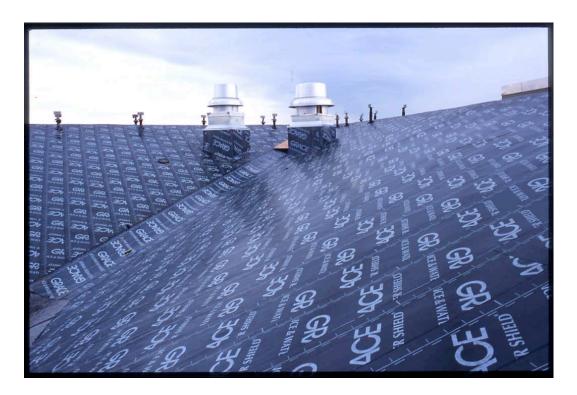
Photograph 73: Large Institutional Roof – Direct Applied Self Adhering Membrane

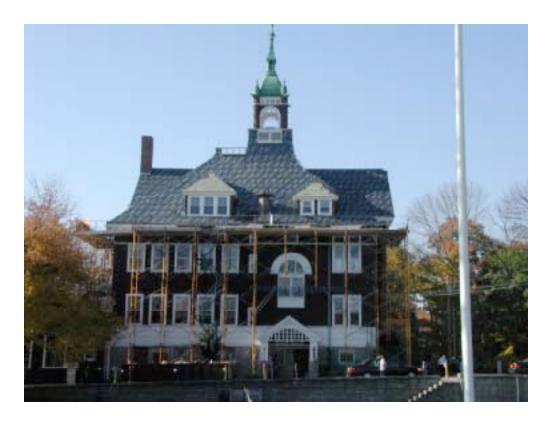
Photograph 74: Complex Roof Geometry – Direct Applied Self Adhering Membrane
